RESIDENTIAL BUILDING SURVEY
OF
An Edwardian Mid-Terrace Property

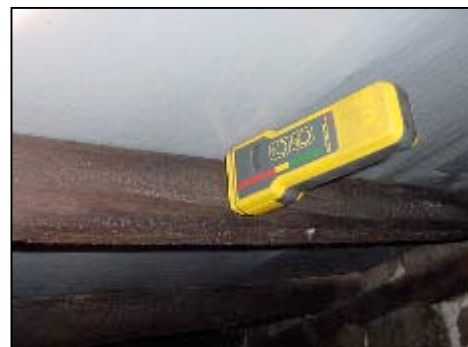
However, our dampness test proved satisfactory.

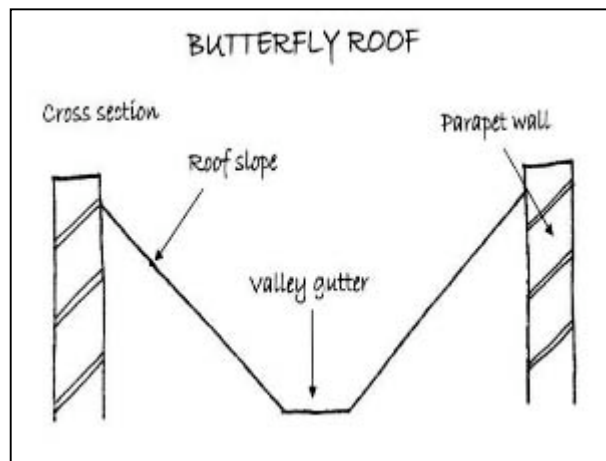
9) **Roofs-Valley Gutter**

Valley gutters are the danger areas with this type of roof. Really, they should be lead and the material should be tucked up behind the roof covering to stop any water getting in even when it backs up.

ACTION REQUIRED: The roof needs to be inspected by a roofing contractor. We will be happy to see any photos that he takes or look at any quotation that he offers.

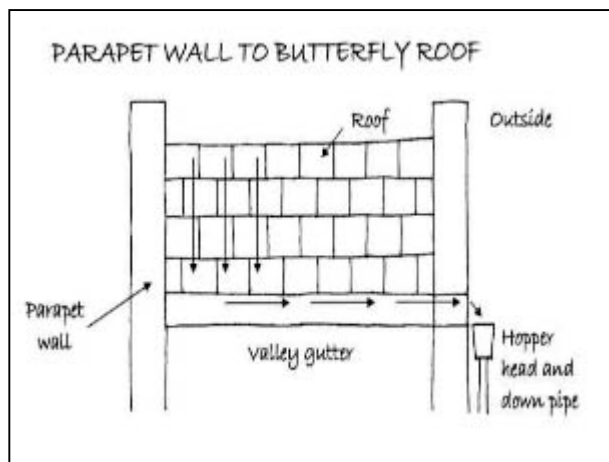
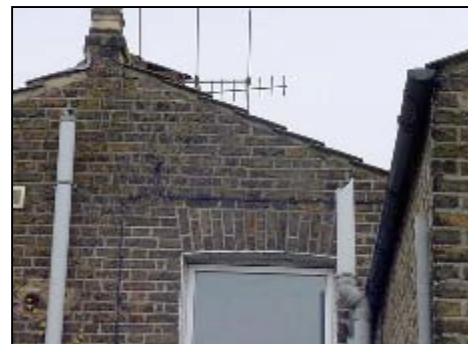
Unfortunately, we were unable to see this roof at all apart from the rear edge and where we could inspect it by getting in the roof. From this we believe it to be a butterfly roof/London roof. Please see our comments within the Executive summary.

Our very limited view of the rear of the main roof.

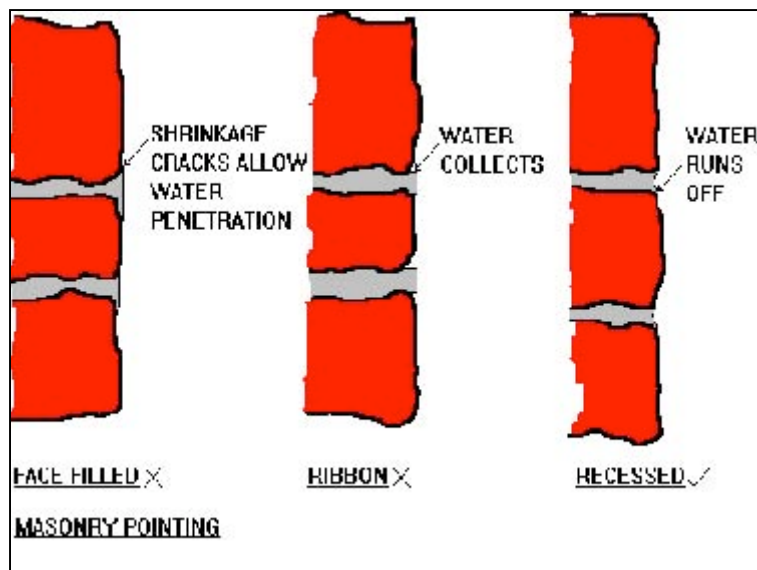
Here is a typical example of how the pointing on the property, as you can see, in some areas is worn away. It is necessary to re-point these areas to stop dampness getting into the structure.

ACTION REQUIRED: When re-pointing is carried out we recommend a lime mortar be used, although there is a fair bit of life left in the existing pointing.

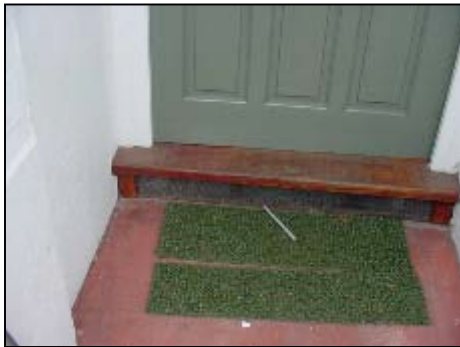
The number of airbricks noted are fairly typical of what we see. We have checked with neighbouring properties and this seems to be the typical number of airbricks.

One of the airbricks.

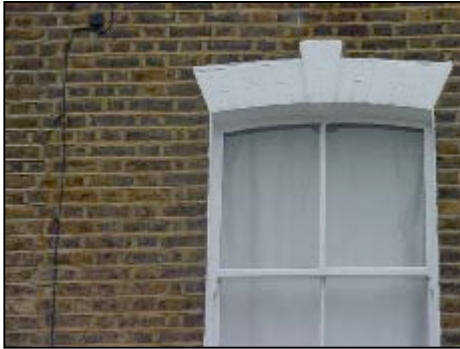
There is a real mixture of windows to this property. To the front they look to be the original sliding sash windows. There is some rot in them but they are certainly saveable. We would not recommend that they are replaced but repaired. To the rear there are plastic and aluminium windows. Please see the Executive Summary for our further comments.

One of the front windows. This looks to be one of the original sliding sash windows. We can tell this due to the thickness or thinness of the profile of the mullions and transoms and also the horns on the bottom of the windows.

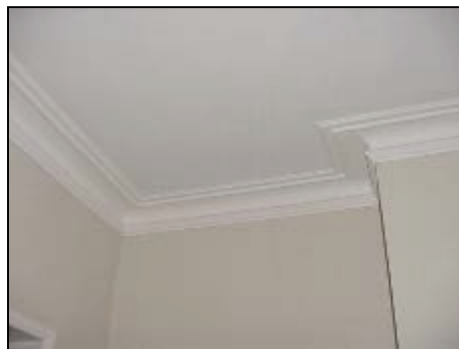
There are some quite nice mouldings that remain to the ceilings.

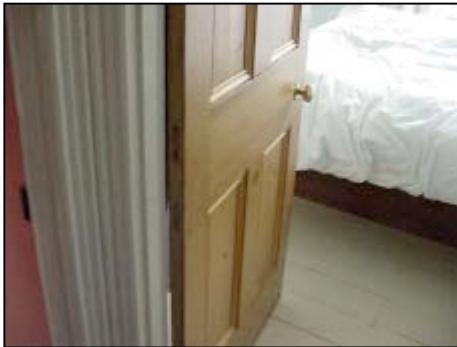
As is the fashion, the doors have been dipped and stripped of their paint, often unfortunately the process also effects the glue that has been used and ironically the timber used in these doors would not have been considered good enough to be exposed in the way it is today originally. We would term these doors to be in average condition for their age, type and style.

Internal doors.

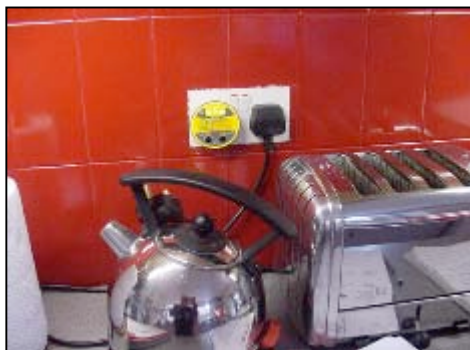
Visible wiring and fittings are dated.

Kettle test.

ACTION REQUIRED: Please see our comments in the Executive Summary. If there is no record of an electrical test having been undertaken within the last five years, it is recommended that the installation be tested by a competent electrician (NICEIC registered) and all recommendations implemented. Thereafter, the installation should be re-tested every five years.
