**RESIDENTIAL BUILDING SURVEY
OF
A GEORGIAN CONVERTED FLAT**

FOR

Mr Flat

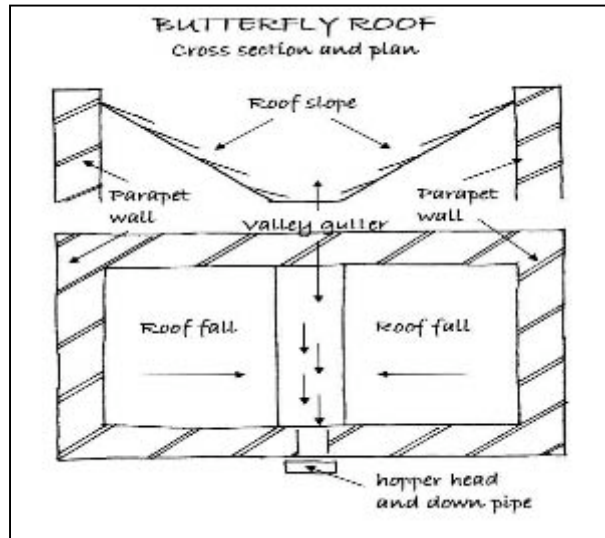
The property has, what is known as a butterfly roof or London roof, they are common in London! Hopefully, the sketch below explains the type of roof better than we can in words.

Butterfly roofs are renowned for their problems, particularly with a central valley gutter. To this one there looks to have been problems to the parapet wall surrounding it, which is also fairly common. Despite our best efforts we were unable to contact the people on the top floor.

ACTION REQUIRED: Your Legal Advisor to specifically request information on the main roof and whether it is a shared responsibility and if so, what are the costs associated with repairing it when it is anticipated it will need to be repaired.

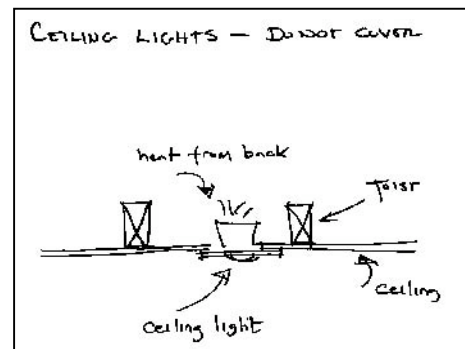
There are some ceiling lights. Older lights such as these give off heat to the rear and can be a fire hazard. You also may wish to add new or additional socket points added as minimal.

Ceiling lights to your property

ACTION REQUIRED: Have the lights checked by an NIC EIC electrician and also possibly extra electrical sockets added.

ANTICIPATED COST: A few hundred pounds.

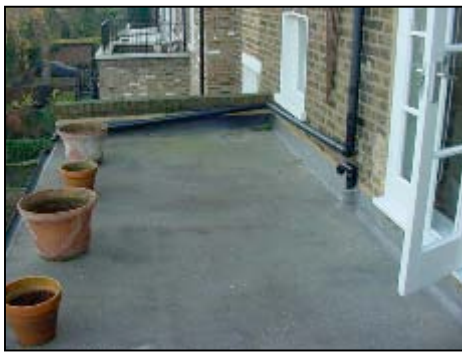
There are several flat roofs to the property to the rear. One forms the terrace and the other forms the roof over the kitchen area.

General view of the flat roof.

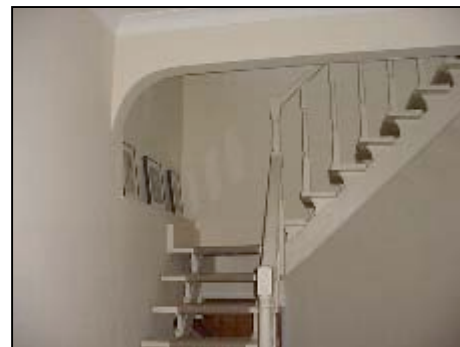
This is a photo of the main staircase. This is actually the staircase from the upper ground floor to the first floor apartment.

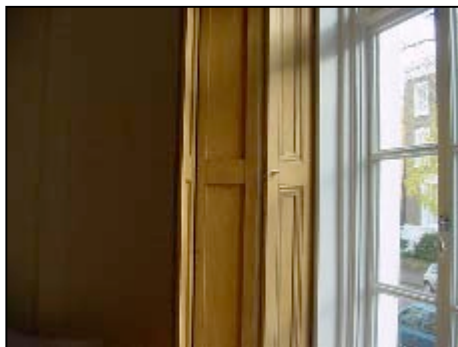
The windows are single glazed and therefore do not have particularly good thermal properties.

The internal shutters are a nice feature of the main windows.
