RESIDENTIAL BUILDING SURVEY OF Post War Semi Detached Property

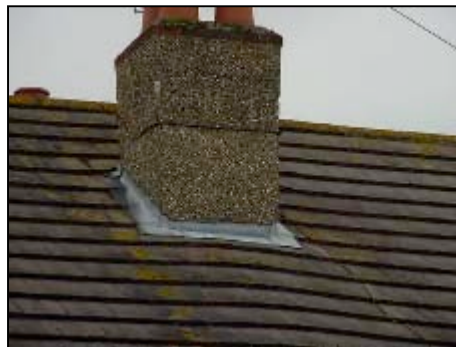
Front Chimney

This chimney has a pea shingle render finish with a lead flashing and three chimney pots. From ground level it looks to be in reasonable condition for its age. Unfortunately we were unable to see the flaunchings and therefore cannot comment upon these.

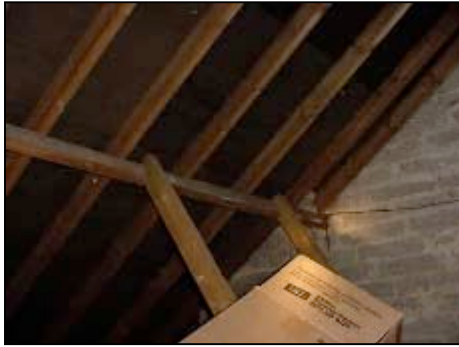
When we inspected the roof space we found a Hessian base Bitumen membrane. This type of membrane has been used since the 1960s. We generally found it to be in average condition, it is damaged in a few places but this is not unusual considering its age.

The common rafters run from the top to the bottom of the picture, the purlins run horizontally. The black area between the common rafters is where the sarking felt is.

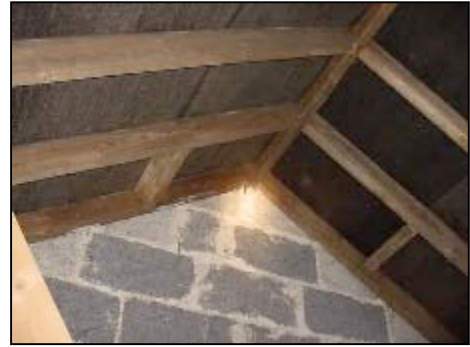
A general view looking towards the gable. Here you can see there is a block inner wall has been used.

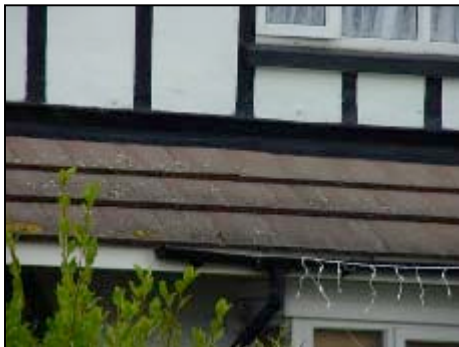
To the front of the property there is a small canopy, this has a single pitch with a concrete tile, which looks in reasonable condition. Where it abuts the main building there should be flashing. There looks to be one but it has been tarred over and difficult to see.

Canopy to the front of the property.

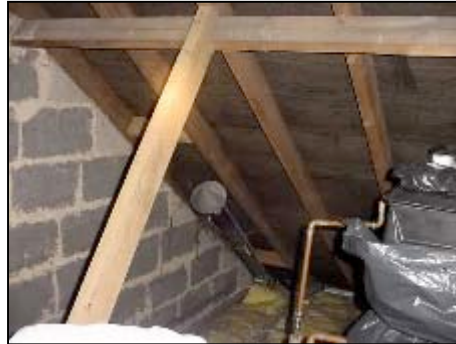
Another view of the roof but here you can see the water tank on the right hand side and the vent on the left hand side.

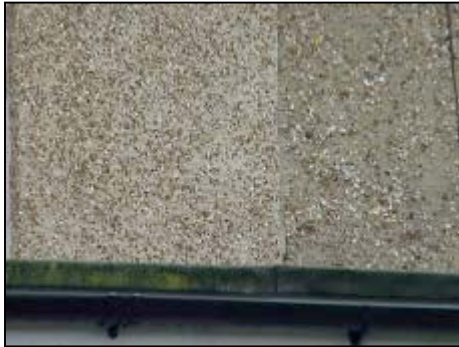
Here you can see on the rear, your render on the left hand side, your neighbours render on the right hand side.

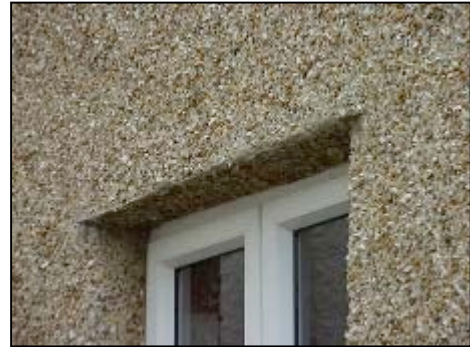
Here you can see the drip detail over the window.

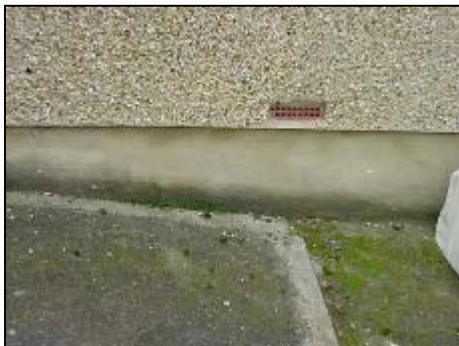
Here you can see the bell-mouth detail to the base of the render

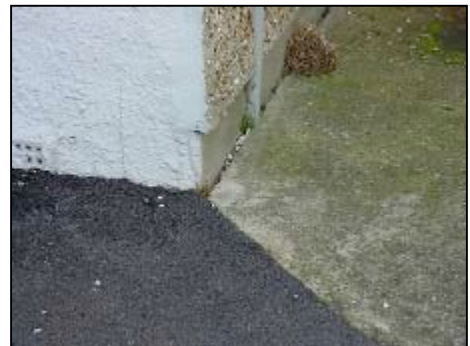
The above relates to the side and rear only, the old render to the front of the property is a different matter and we feel it has now come to the end of its usual life. However, you can keep it going for many years to come by redecorating regularly and patch repair.

A view of the bell-mouth render where it meets the front render where there is not a bell-mouth.

ACTION REQUIRED: The render needs replacing, please see our comments in the Executive Summary.

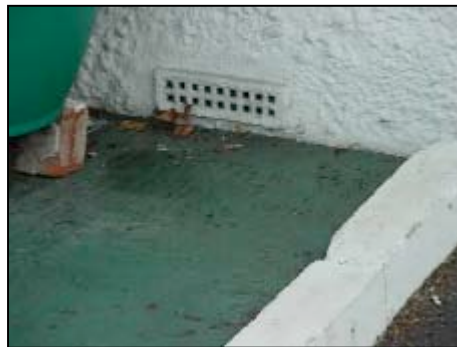
Airbricks have been incorporated in the external walls at low level. Sub-floor ventilation is essential in discouraging rot and on no account should the airbricks be obstructed. In this case, the airbricks are slightly low to the front and the side of the property therefore it will allow rain etc to get in them. It is literally running off the car parking area. Therefore some sort of action needs to be put in place in this area. We have simply seen bricks around them; please see our further comments in the Executive Summary.

An airbrick to the front of the property

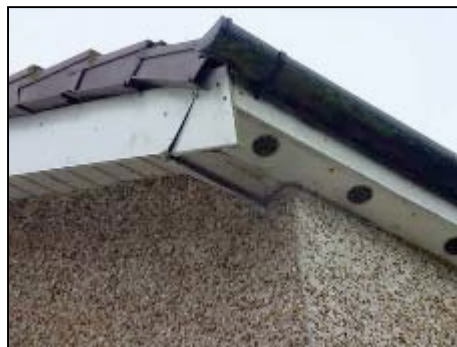
It is now a requirement under the current Building Regulations to have ventilation within the roof space. This looks to have been carried out in this case with ventilation to the soffits, which is quite common. You should also ensure that there is no insulation internally blocking this ventilation. As we did not feel there to be a through draft on the day we did the survey.

A view of the fascia and soffits boards.

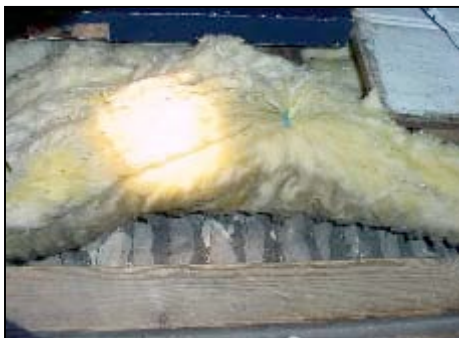
Here you can see underneath the insulation the back of the lath and plaster

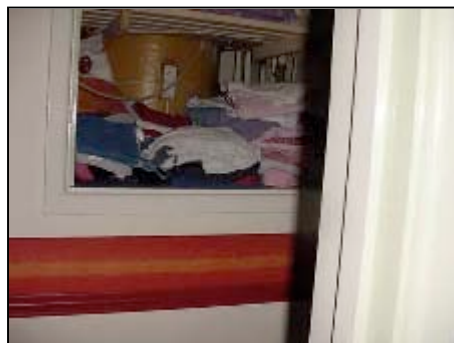
The water cylinder is located at the top of the stairs and is factory lagged and we had a limited view of it.

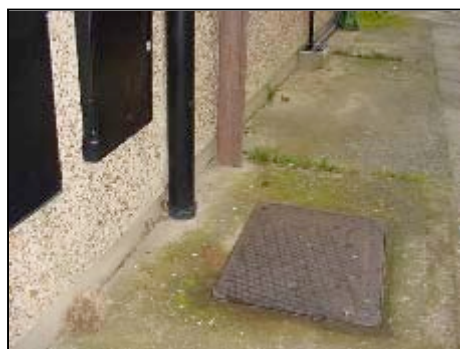
Inspection chamber close to the house

This was a fairly shallow cement finish, which was free flowing at the time of our inspection.

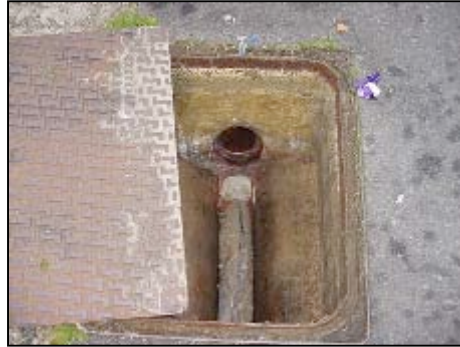
Inspection chamber at the end of the drive.

This looked to go into a back inlet gully; again, this was free flowing at the time of our inspection and was finished with concrete.
