# COMMERCIAL BUILDING SURVEY

**A Two Storey Hotel situated in Southport**

**GEM Associates Limited**

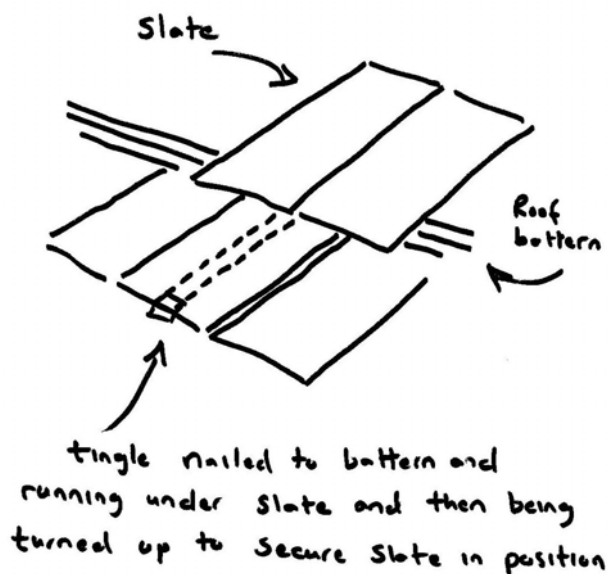
#### **Roof tingle**

The pitched roofs have been considerably repaired due, we believe, to nail sickness and dampness getting into the roof valleys; water was literally sitting in the valleys at the time of our inspection.

Nail sickness is the rusting of the nail fixing points. These have been secured in place by lead tingles.

Generally if a roof has a dozen lead tingles we would say that it needs re-roofing. In this case we believe that this limit has been exceeded but we do believe the roofs have some life left in them and could be repaired and amended over the years. Ultimately it will need to be substantially repaired or replaced, depending upon how long it is left.

**ACTION REQUIRED:** Repairs are needed to the pitched roof. They don't need to be carried out instantly but they certainly need to be carried out within the next three years, possibly sooner. We were quite surprised that we did not see much more dampness inside.

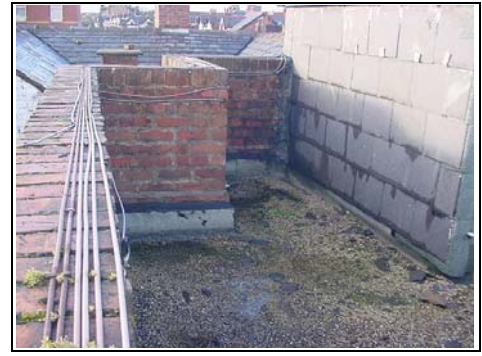
### Flat Roof Adjacent to the Shop

Whilst we haven't had direct access to this roof we were able to view it from the rear of the property. We noted moss sitting on this roof, which indicates that it is a 'flat' flat roof without the rainwater being able to discharge from it.

**ACTION REQUIRED:** We believe that patch repairs are required to this roof at present and ultimately we would recommend again that insulation cut to falls is added and a high performance felt is used.

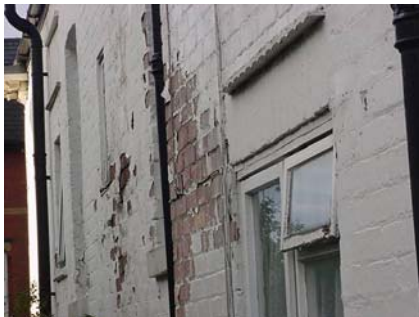
There is a mixture of gutters, from the original cast iron to a more modern plastic. The gutters look to be leaking as can be seen from the paint coming away from the walls. There are also signs of rust to the cast iron. The cast iron is suffering from a general lack of maintenance.

Paintwork coming away from the walls due to leaking gutters and downpipes

**ACTION REQUIRED:** We recommend that the cast iron is maintained as in a well maintained condition it will last far longer than the plastic.

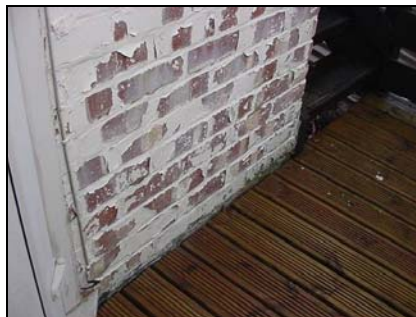
Leaking gutters and downpipes causing paint to come away from the walls

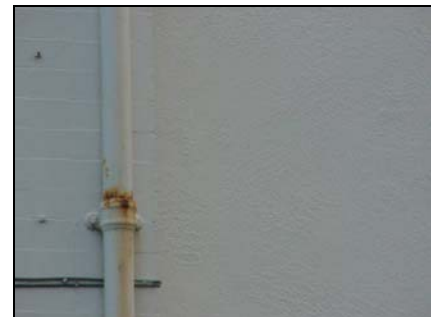
Rusting downpipe

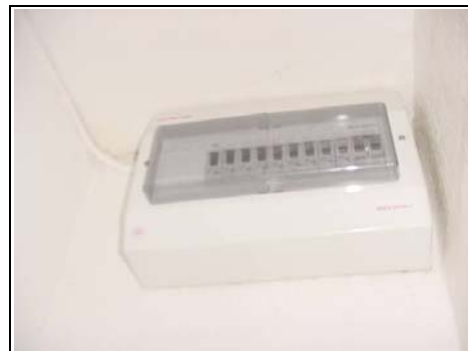
One of the four up to date fuse boards

Whilst we don't carry out an Institute of Electrical Engineers test and report (and we would recommend this is carried out, making sure the electrician is NICEIC or similar approved) we have carried out a basic visual check and earth check and we were pleased to see from our inspection of the five fuse boards that four of them were relatively new and would estimate that they were probably replaced in the mid 1990s to early 2000s.

**ACTION REQUIRED:** As at our discussion, we recommend a full Institute of Electrical Engineers test by an NICEIC (or similar) approved electrical contractor. We spoke to you about the need for the electrical contractor to also offer commonsense advice.

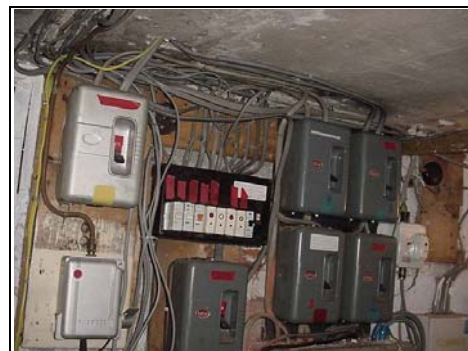
The fifth fuse board located in the cellar is dated, probably from the 1960s and needs replacing.

Dated 1960s fuse board in the cellar (the fuse board is to the centre of the photo).

We recommend that the dated fuse board in the cellar be replaced.

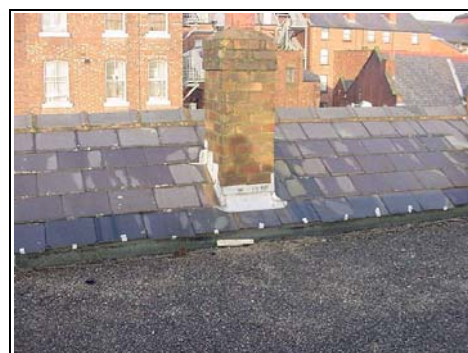
#### **Chimney Two – Front Left Hand Side Chimney**

This is a brick chimney with a single chimney pot and a lead flashing. This chimney is in average condition.

Located to the left hand side

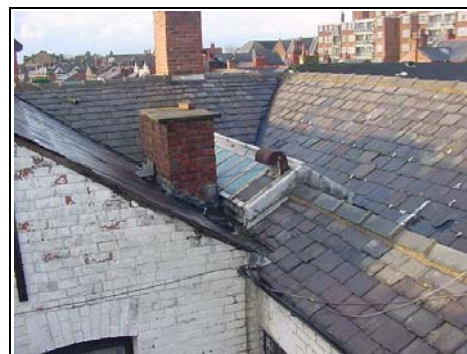
### **Chimney Four – Hidden Chimney**

This chimney is brick built and has been capped. There is a very awkward detail where the chimney meets the valley gutter and a roof window. Although the base has a lead flashing we do believe that dampness is getting in in this area (we have not had access to this roof void).

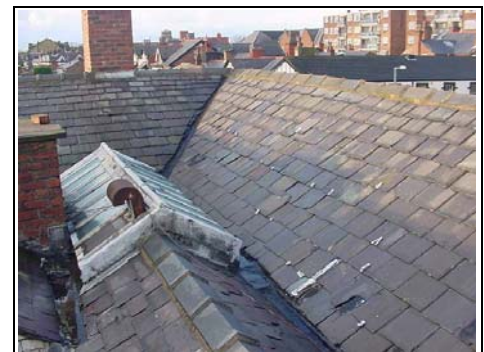
There is also a purpose made roof window on the ridge of the roof adjacent to two valley gutters. These are typically made in timber and then have lead applied to them. In this case from the detail it looks to be lead.

We did not think it would be safe for us to access this roof window via the valley gutter.

Incidentally you can the damage and deterioration to the slate roof on the right hand side and a number of tingles. Please see our comments in the Executive Summary for further information on this.

**ACTION REQUIRED AND ANTICIPATED COSTS:** We suspect this roof window is leaking although we have not been able to access it closely either externally or internally. We would however recommend the provision of £2,000 - £4,000 to carry out associated repairs, but the problem really is the configuration of the roof. Please see our further comments in the Roof Covering Section.

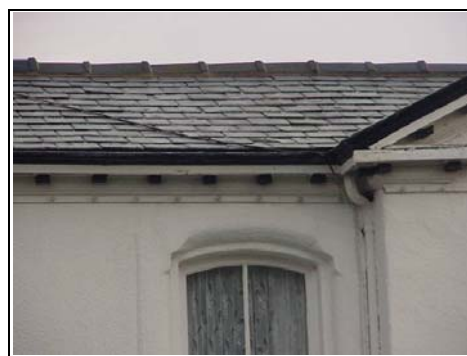
Main Roof

The main pitched roofs are clad with a quarried slate. The slates sit fairly true however there are many tiles that have been displaced or cracked. Considering the property's age the roof is in below average condition and needs a general overhaul.

**ACTION REQUIRED:** We believe there is probably about a week's work of repairing and replacing slates. The big difficulty is that sometimes more damage can be caused than good as slates are broken as the roof is accessed to carry out other work.

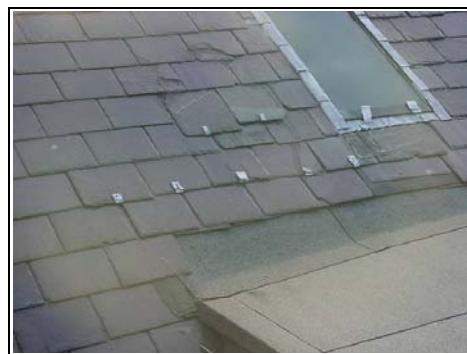
Close up of lead tingles to roof

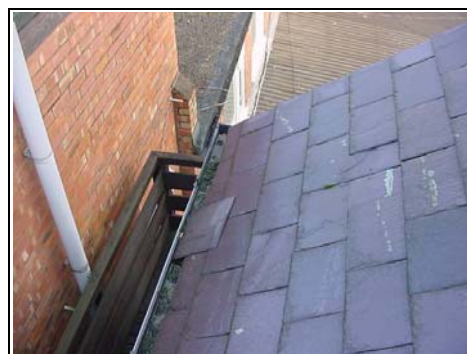
Close up showing slipped slate

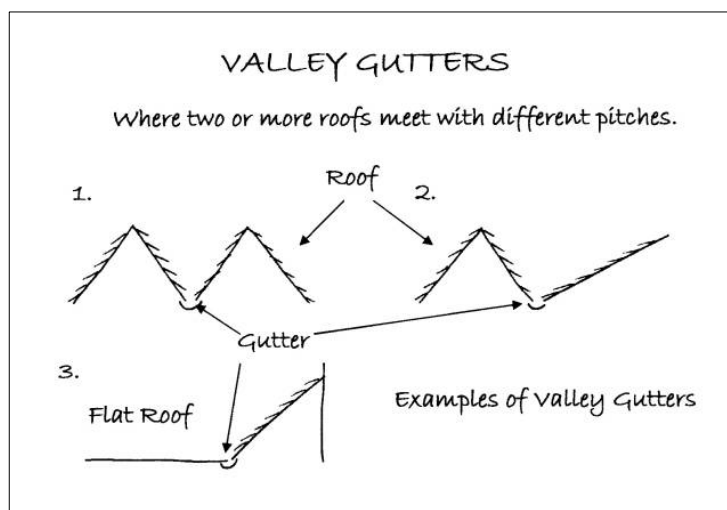
Valley gutters occur where two roofs join and these are generally considered weak areas. In this case the valley gutters are a terrible detail and water is literally sitting in them.

We would add that we had a limited view of the valley gutters but we could see water was sitting in them. This may simply be vegetation which can be cleared but it looks to be a more long term problem as we could see dampness within the roof of the one high level pitched roof that we could access (on the front left hand side).

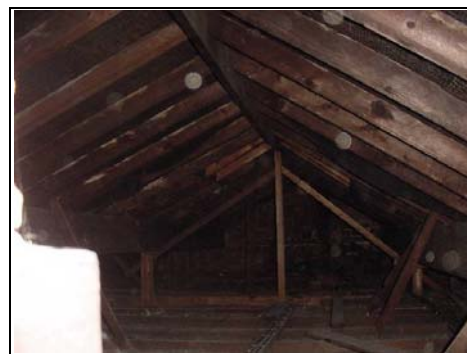
Here we're looking at the base of the pitched roof where it meets the valley gutter and you can see the dampness.

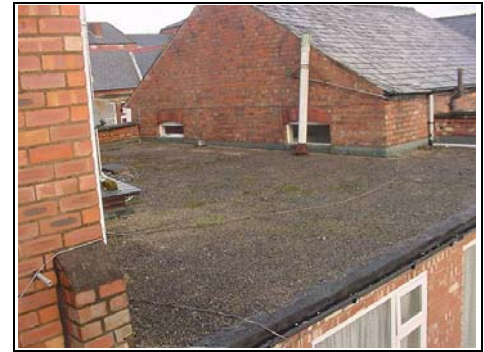
Flat roof adjacent to shop

Although we did not physically get on this roof we could see from the rear fire escape that moss is sitting on the roof which indicates that the roof is too flat. We would add an insulation cut to falls and a lead flashing around. The wall that cannot be seen on the photo is the rendered wall that has been affected by the dampness coming from the parapet wall. It is particularly important that this area is made watertight.

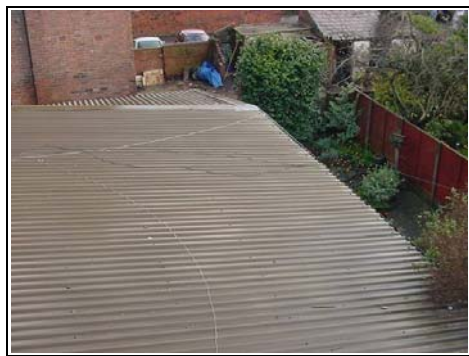
Metal roof

Whilst the metal roof looks in reasonable condition externally when we inspected within the roof space we noted that there is dampness getting in. This can either be from rain or condensation. As the property has been unoccupied for some time we suspect it is likely to be rain damage. This is causing rot into the timber members and also rusting of the structural steels.

As we would expect there was no underlayer in this roof.

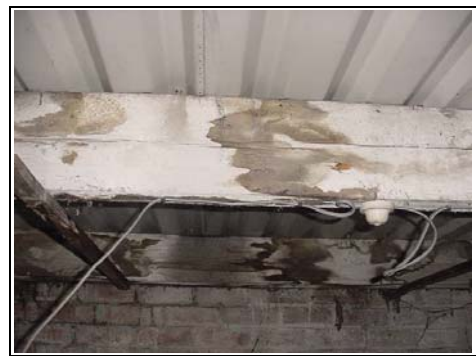
Dampness coming in

Dampness

Corrosion to the metal 'I' beam

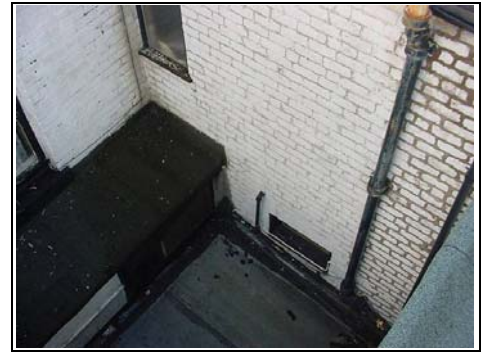
Downpipe

When we were on the main roof we noted that there is a central open area that has various roofs in. It looks to have suffered in the past from leaking gutters.

**ACTION REQUIRED:** We would recommend that a wide gutter is added (often known as a deep flow gutter) as this area really does need a permanent solution as any problems will be unseen until major problems occur. It would also be worth repairing or replacing the cast iron downpipe.

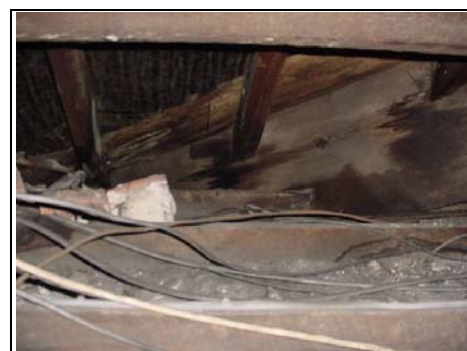
Dampness was found

Our examination is limited by the general configuration of the roof, as mentioned what we could see was generally found to be in below average condition considering its age. We found dampness due to the valley gutter. Please see our other comments on this in the Executive Summary and the Roof Coverings Section.

**ACTION REQUIRED:** The valley gutters need to be made watertight and possibly alterations to be carried out to the roof configuration. We would also recommend adding ventilation and insulation to the roof space.

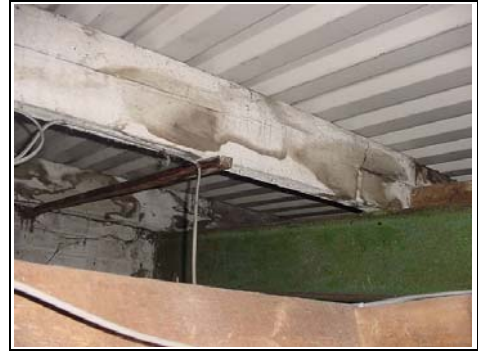
Looking into the roof void below  
the metal roof

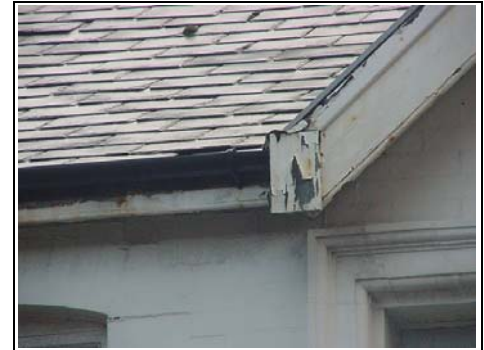
The property has a mixture of the original cast iron gutters and downpipes and the more modern replacement plastic gutters and downpipes. What we saw of the gutters and downpipes are in a poor condition and therefore they are causing deterioration to the property.

Plastic gutter

**ACTION REQUIRED:** From what we saw of the gutters and downpipes we believe they are leaking, as you can see by the above photos. Generally it is worth looking at replacing with a wide or deep flow guttering whilst the roof work is being carried out; also many of the gutters need realigning. Please see comments in the Executive Summary.

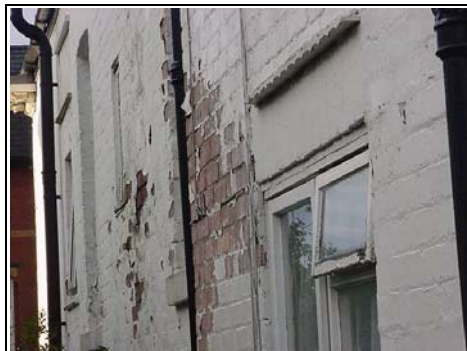
Likely to have been caused by leaking  
gutters and downpipes

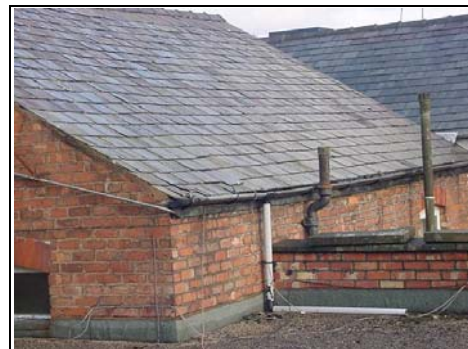
There are a mixture of soil and vent pipes from cast iron to asbestos to plastic. They appear to be satisfactory where a surface inspection is possible, although the cast iron ones are rusting.

The plastic ones have missing top sections which should project approximately one meter above the roof level to disperse smells etc.

Plastic gutter and downpipe and cast iron soil and vent pipe and an asbestos soil and vent pipe

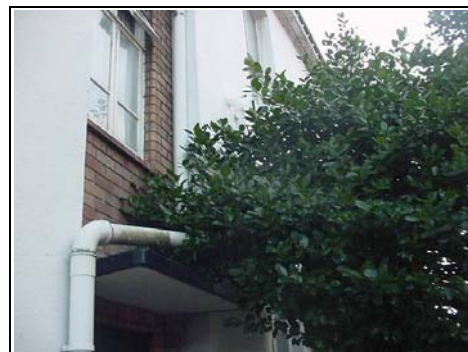
You also have a very long soil and vent pipe run to the left hand side of the property.

Soil and vent pipe disappearing through the trees

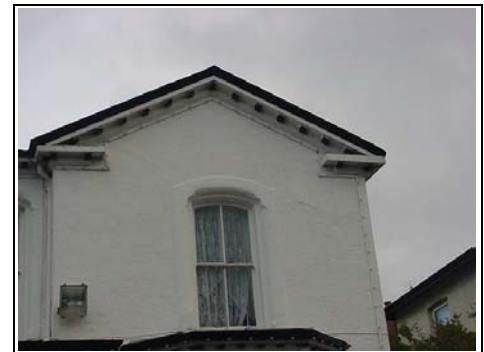
The areas that we weren't able to check with a tap test were at high level; we noted to the front right hand side that there were undulations in the render which indicate that it has either been repaired or it is blown or blistered.

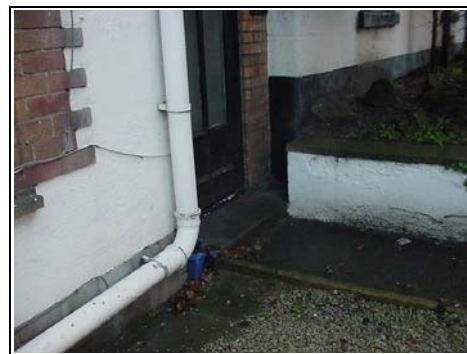
Relatively modern render

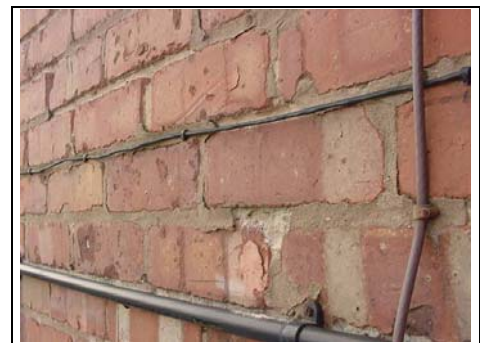
We did note that there has been some repointing to the brickwork in a cement mortar. This is fairly common and is often used where lateral dampness (dampness coming through the wall) has been caused.

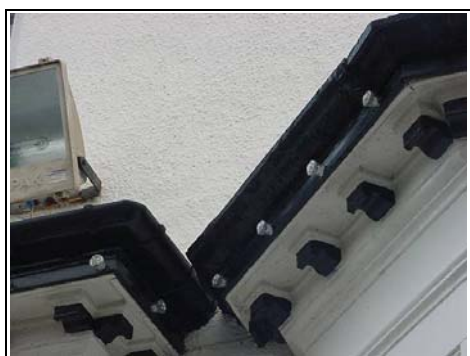
The property has painted timber fascias and soffits; some were in surprisingly good condition and some had paint peeling, as we would expect. No doubt caused by deteriorating or leaking gutters.

Fascias and soffits to the front in relatively good condition

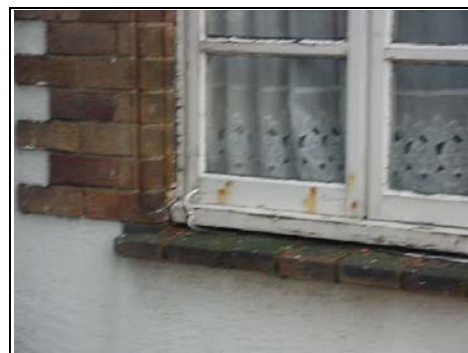
The property has a mixture of painted timber windows, which are single glazed; these are divided between the large sliding sash windows to the front and front side of the property and then more modern timber casement windows, probably from the 1970s. As is always the case these timber windows rot very quickly and whilst they are 'saveable' it may not be the most economic way to proceed.

**ACTION REQUIRED:** We would recommend you look at replacing with double glazed plastic windows or better quality timber windows. Please see our comments in the Executive Summary.

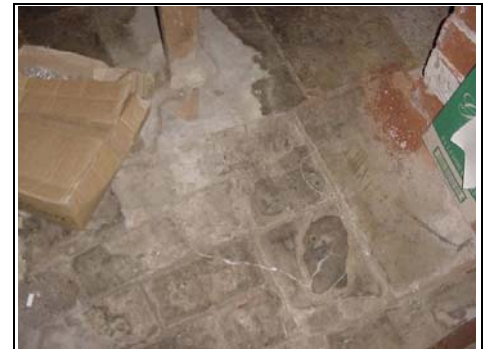
Floor to cellar

No sump pump was noted to the cellar area. This does mean that if the cellar floods you will have a problem getting rid of the water.

**ACTION REQUIRED:** You should specifically ask the owner if there is a sump pump or a low point and whether the cellar has flooded.

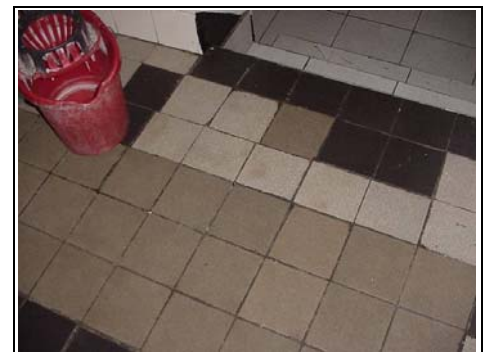
Tiles to catering kitchen – ingrained dirt requiring a deep clean.

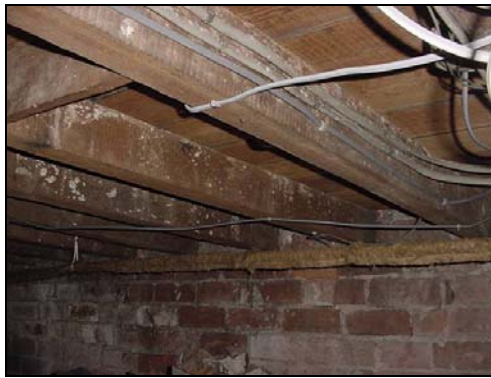
Under floor taken from the cellar area

We noted new timbers under the bay window area. The owner when questioned confirmed that they had been replaced.

Given the age of the property the timbers are likely to be embedded in the walls, which means wet rot is likely. Without opening the floors up we cannot comment further.

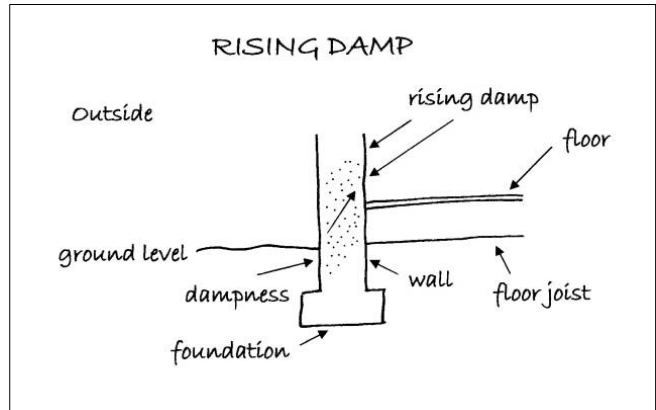
We have carried out tests with an electronic damp meter to a random selection of areas and we found rising damp.

We found rising damp to the front and side of the property

**ACTION REQUIRED:** Please see our comments in the Executive Summary.

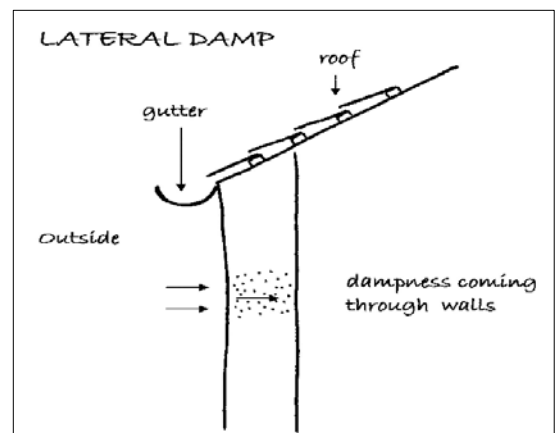
We noted some areas of damp, when testing with the electronic damp meter, and also some areas of blown plaster as well.

**ACTION REQUIRED:** Please see our comments in the Executive Summary.

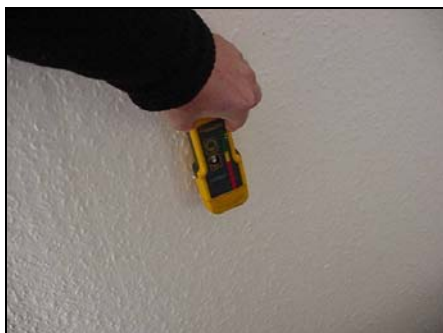
Checking for lateral dampness

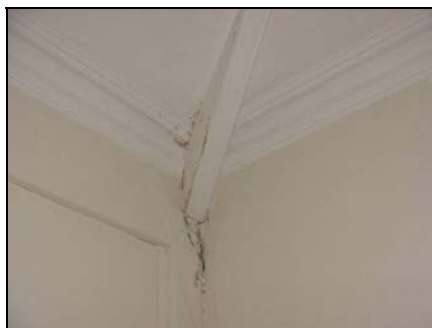
Dampness coming in via the valley gutter

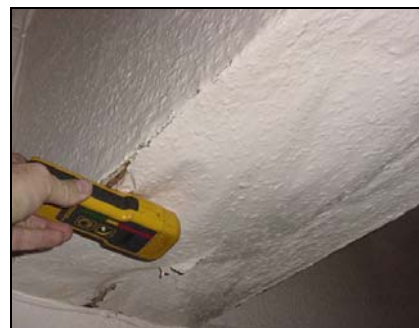
Dampness near rear fire exit coming in from valley gutter above.

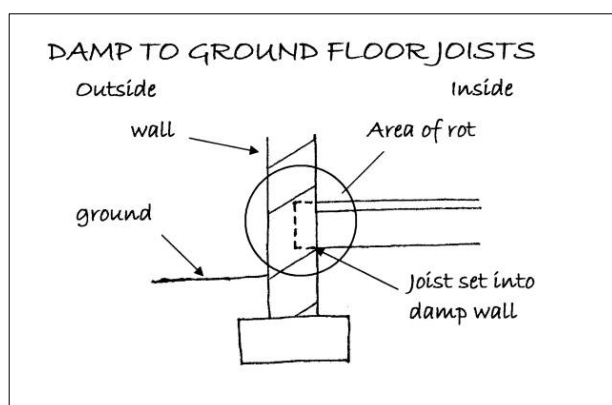
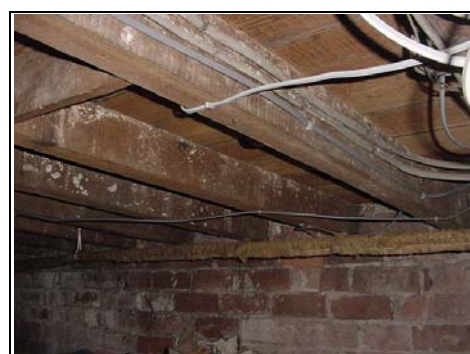
We would reiterate that we did not note a sump pump and we believe some of the joist ends will have started to rot due to the embedded timbers.

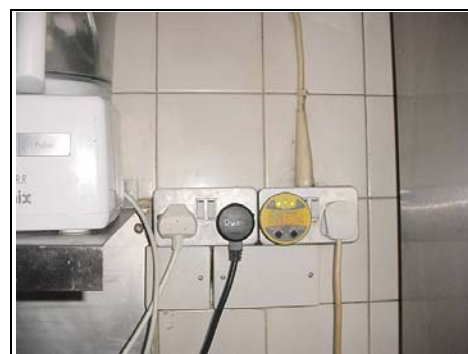
We carried out an earth test in the kitchen area to the socket point that is normally used for the kettle and this proved satisfactory.

**ACTION REQUIRED:** As the property is changing occupancy an IEE report should be carried out by a NICEIC registered and approved electrical contractor.

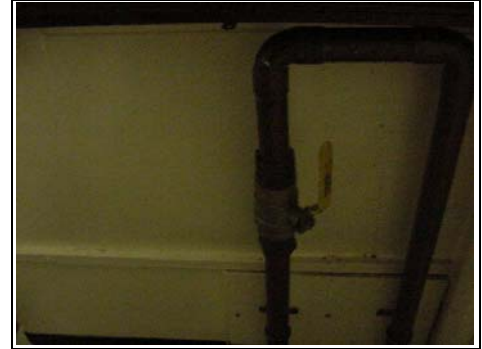
The gas emergency cut off is located near the entrance to the cellar just behind the reception.

**ACTION REQUIRED:** As a matter of course it is recommended that the entire gas installation is inspected and made good, as necessary, by a CORGI registered contractor. Thereafter the installation should be serviced annually.
