# COMMERCIAL BUILDING SURVEY

## Industrial Unit, Warwickshire

***GEM Associates Limited***

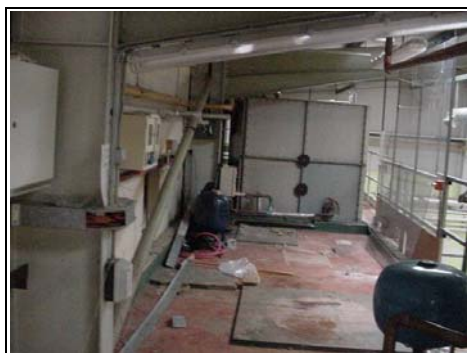
View of Laundry Mezzanine Floor  
To be removed

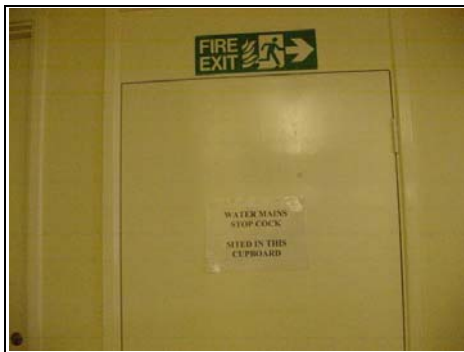
Services Cupboard  
Locked, no access possible

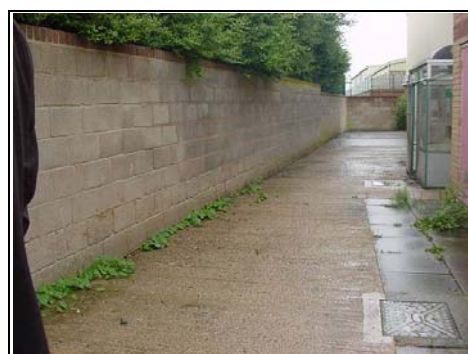
From our understanding following discussions with the Freeholder's surveyor, we believe that the rear retaining wall has been added.

**ACTION REQUIRED:** As there is a sloping bank behind the wall we would suggest that weep holes are added into the wall. These are simply small holes which allow the build up of water to discharge rather than pushing the wall over.

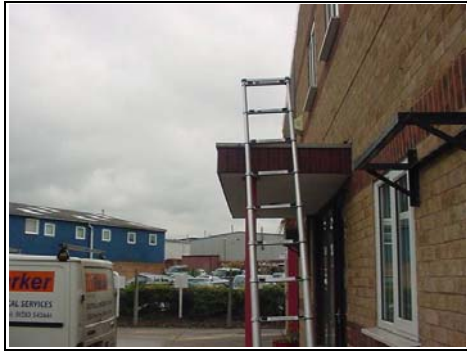
Entrance Canopy

You may wish to consider replacing the canopy altogether, alternatively some drainage point needs to be provided. As an aside we have seen a glass entrance canopy used very effectively with lighting to re-brand a property's image.

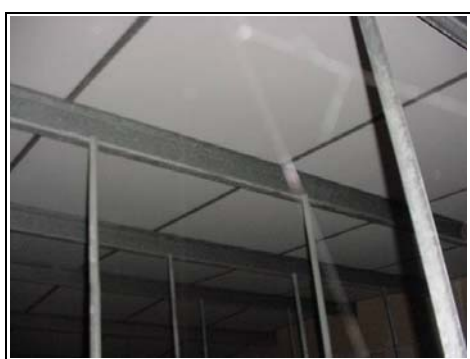
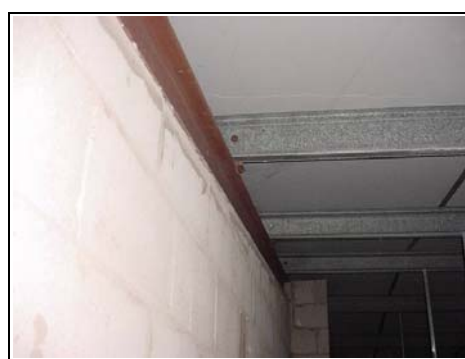
Looking at the Ceiling within the Dining Room area  
above the suspended ceiling

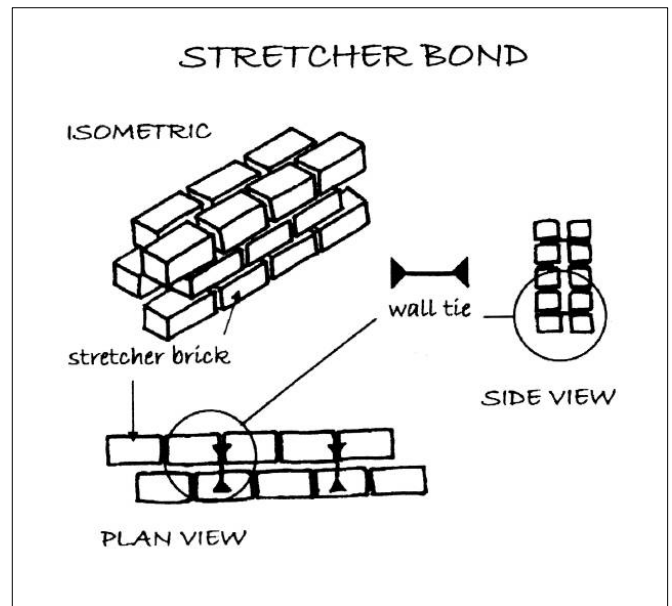
Front left hand side Brickwork – Minor movement probably due to the brickwork not being tied in properly and / or impact damage.

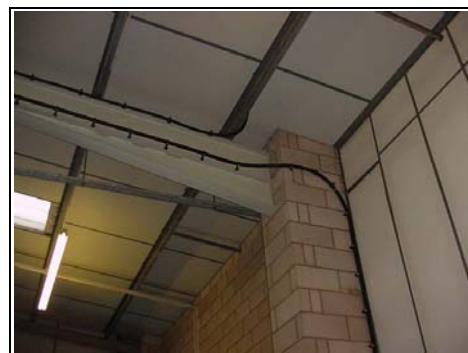
Structural Portal Frame

We expect this to be a high level which it isn't in this instance. Depending on the type of work you are carrying out we would recommend the remainder of the frame is clad. You need to take special advice on this as it depends on work you are carrying out on the property.

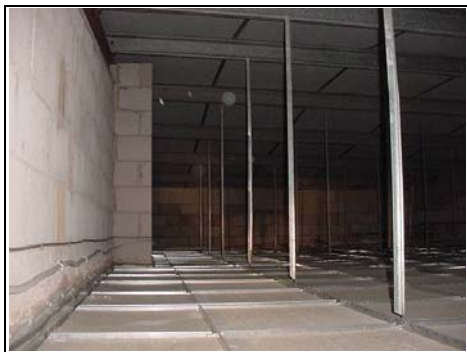
Suspended ceiling above kitchen  
and dining room area

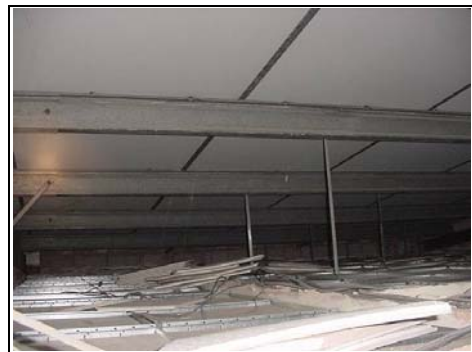
Suspended Ceiling above the dining  
area looking centrally along the wall

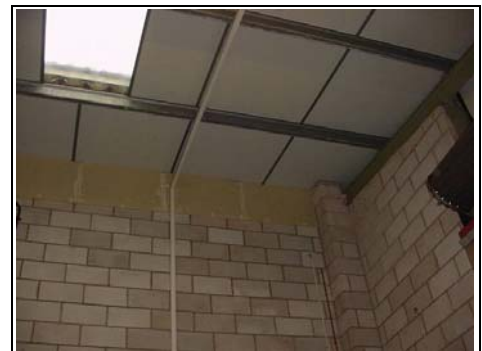
A mixture of blockwork and cladding please see our comments in the Executive Summary and concerns about asbestos being within the structure.

Internal view of blockwork

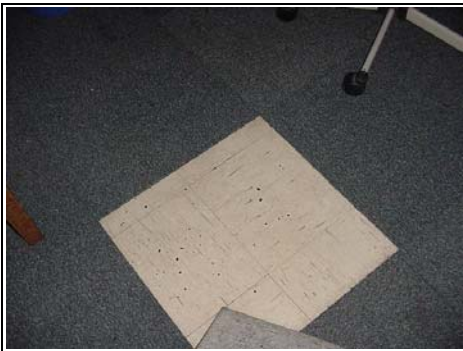
Within Office Two

We are concerned about the vinyl finish once the tiles have been removed within the laundry area and the general work area, the appropriateness of this to and your business (and not to mention the re-sale market). We also reiterate our comment about the floor lifting to the front right of the property.

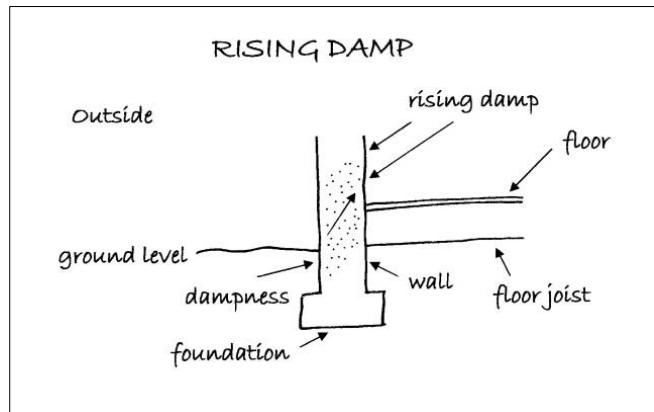
The access to some of the perimeter walls was limited. The areas where we carried out a random testing we didn't find any significant rising damp however from locations of the damp proof course on the left hand side of the property we believe dampness will occur. Probably currently sitting within the raised floor to the laundry area.

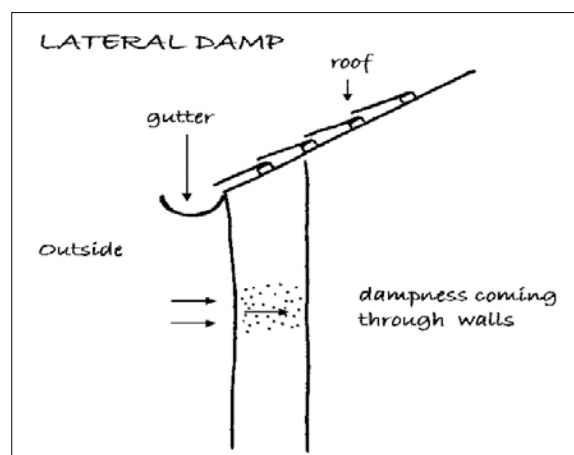
We were unable to take readings as the walls are clad.

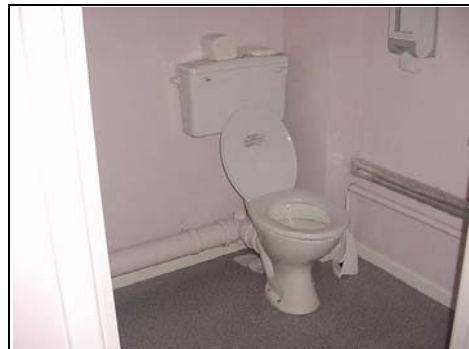
There are two sets of toilets are remaining, both are located on the right hand side of the property in, utilising white sanitary ware. Generally in acceptable condition though you may have different standards to your staff. We would comment that the showers look dated but you can decide whether you wish to keep these. We suggest that you replace them if you do decide to keep them.

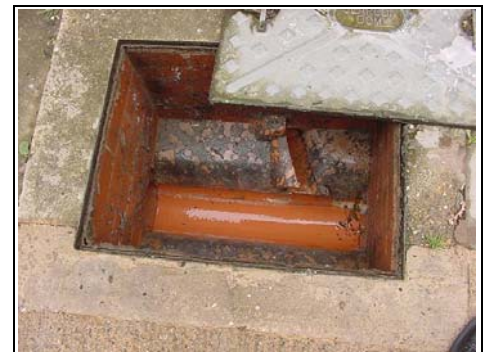
We duly lifted the light manhole cover and found it to be clear at the time of our inspection.

From what we could see it is brick built.

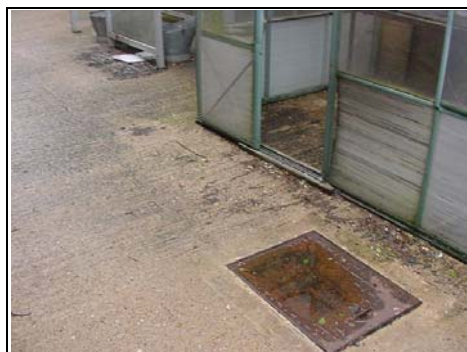
## **Inspection Chamber / Manhole Two – To the Rear near the Smokers Shelter**

This is a lightweight manhole; we have only undertaken a visual inspection.
