# COMMERCIAL BUILDING SURVEY

of  
A Wet Trade Driven Public House

**GEM Associates Limited**

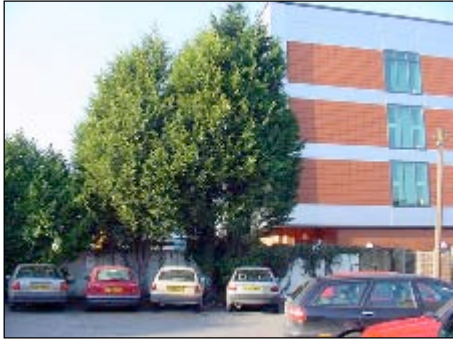
You can see the sheer size of these compared against the multi storey offices.

**ACTION REQUIRED:** An arboriculturist to inspect the trees in the summer and advise on the lopping work required.

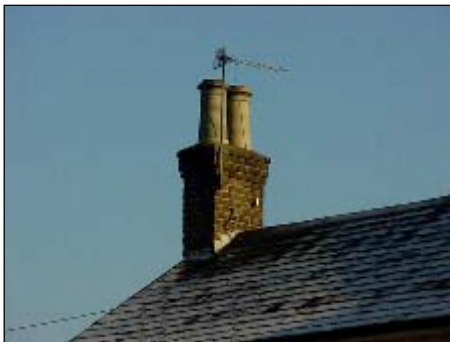
## **Chimney Four**

This is just about visible on the rear of the property and we literally had to get on ladders and climb up onto the roof to see it properly.

This is probably in the worse condition of the chimneys and needs a lead flashing.

**ACTION REQUIRED:** A lead flashing is essential in this instance as we could clearly see in the roof that the flashing is leaking.

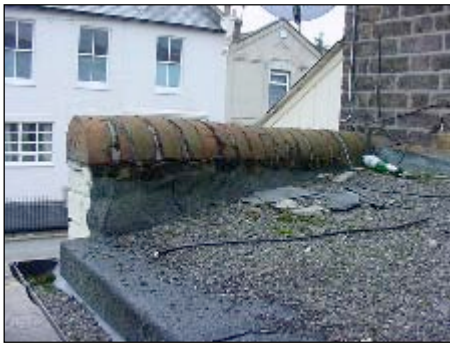
### **Parapet Wall to the Front of the Property**

There is a small parapet wall to the front of the property to the right hand side. There has been some movement in this due to its exposed position. We believe that if the felt flashing is removed and a proper lead flashing put in its place this should be resolved.

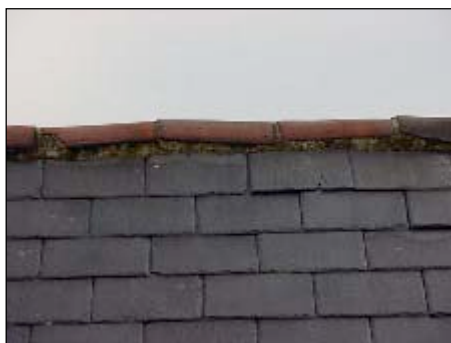
We noted light through some of the ridge tiles, although not that many given the age, so they have probably been re-bedded at some point.

Predominantly there are good areas of slate work, the ridge looks to have been repaired over the years using what is known as a hog back tile. There are a mixture of different types of these.

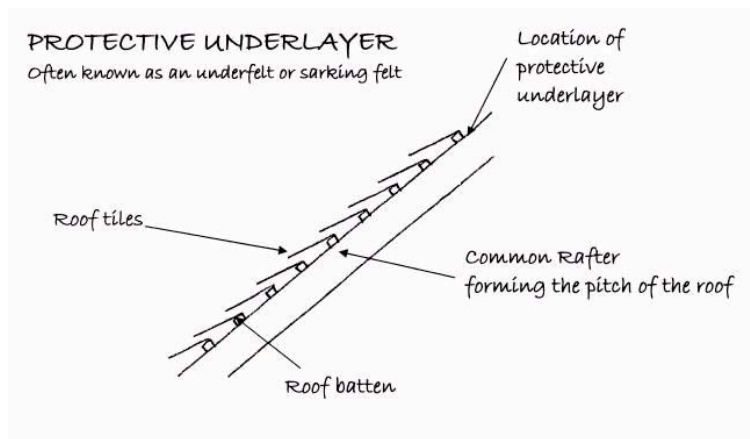
When we were in the roof space we noted a Hessian reinforced sarking felt, which indicates that the property has been re-roofed within the last 30-40 years.

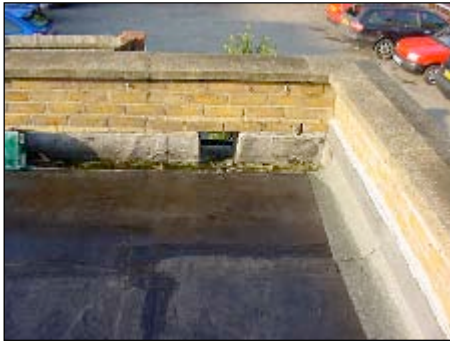
General picture of rear roof.

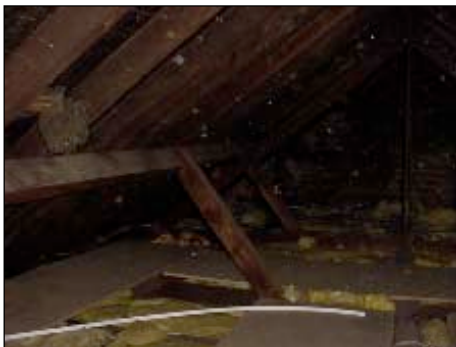
General view of the roof. You can see the purlin running on the left hand side horizontally to the rear and the common rafter sitting on top of it. There are prop timber supports running at 45 degrees from the purlin. To the far right hand side you can see a thin cast iron pole giving extra support to the whole structure.

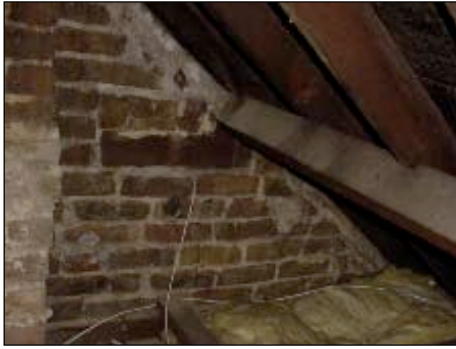
This is a close up of one of the purlins which bonds into the wall.

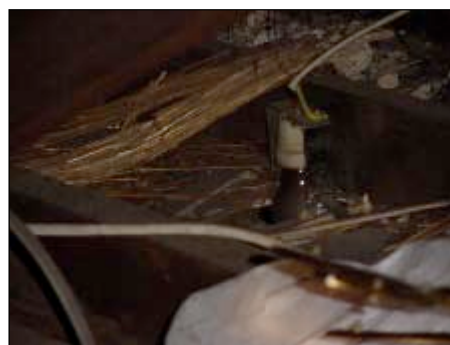
We are concerned with the electrics for the surface mounted lighting found in the first floor. If you look closely at this photo you will see that the live red wire could easily be knocked and cause a fire. Funnily enough there is straw nearby. More modern versions of this type of light have the wiring etc encased at the top. We recommend these be replaced.

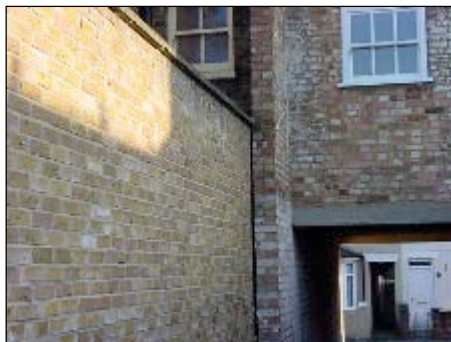
Left hand side

We went onto the adjoining land on the left hand side through the archway to carry out an inspection of the property. Here we found that a lintel has been built into the party wall. This has formed or caused a point load, which has resulted in a vertical crack.

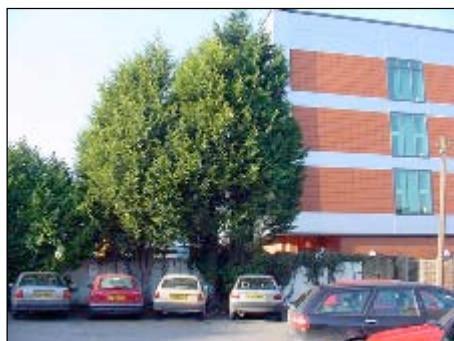
You can see the sheer size of these compared against the multi storey offices.

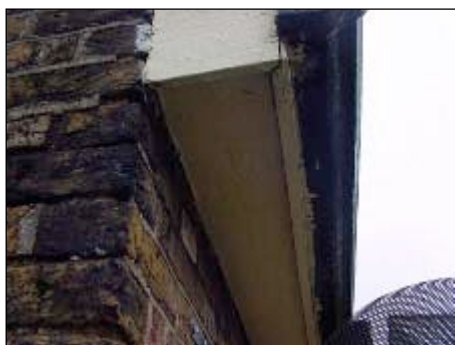
The fascias and soffits are painted timber. Most of the fascia is hidden by the rainwater gutter, however they appear in reasonable condition. We are advised that the present landlady had not had them re-decorated in the past few years she had been there. A customer believed that external re-decoration was last carried out about five years ago. Most leases have an external re-decoration clause that is usually about every five years, so you should check this to make sure you do not have to paint the property.

A view of the fascia and soffit.

**ACTION REQUIRED:** Your Legal Advisor to check when the next re-decoration is required under your lease terms.

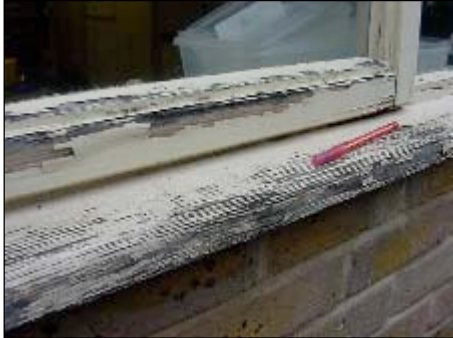
A view of one of the newer windows.

**ACTION REQUIRED:** We suggest a good quality joinery firm would take the best part of a week to sort these windows out. We feel it would be well worth spending the money on the older windows, but not so much on the more modern extension windows.

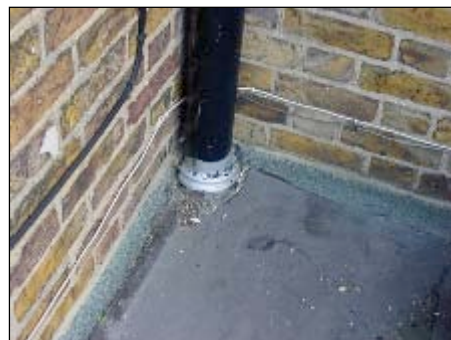
There are various soil and vent pipes. Our main concern is how these go through the rear flat roof and this flashing detail should be tidied up when the roof is repaired.
