COMMERCIAL BUILDING SURVEY

OF
A 17th Century Public House

FOR
Mr H

GEM Associates Limited

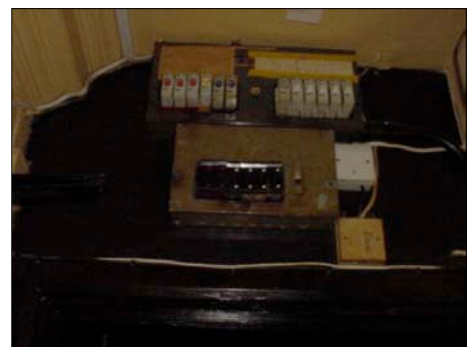
From our visual inspection, we would consider the electrical installation not to NIC EIC standards.

ACTION REQUIRED: Have an Institute of Electrical Engineers full report carried out on the property, and any recommendations actioned.

ANTICIPATED COST: In the region of £250 to £300 for the circuit board, plus any other recommendations that are made.

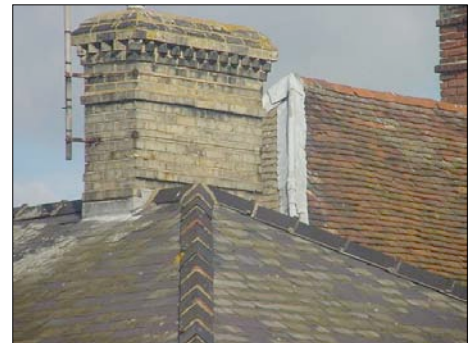
Chimneys Three and Four – To the rear left hand side of the property

There are two substantial brick chimneys built in a white brick, each with one chimney pot. They are strapped; from the sides we could see they looked in reasonable condition, with the exception of the rear right hand one requiring the cement flashing to be replaced with a lead flashing.

ACTION REQUIRED: We would, given the size of them, recommend a close inspection before committing to the lease. You will need a builder with a set of long ladders to view them properly.

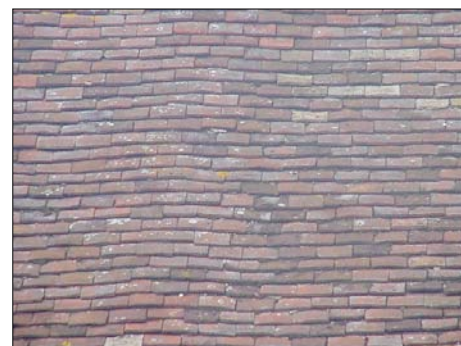
A close-up of the roof

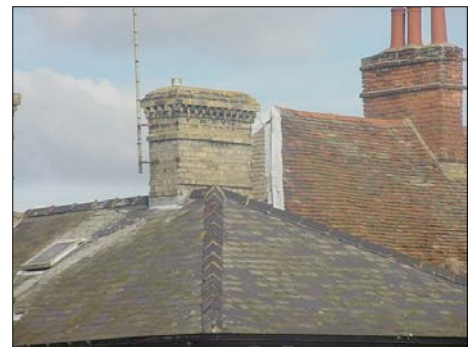
This roof is pitched and clad with slate. All things considered the roof looked in good condition as viewed from ground level, considering its age, type and style. However, this type of shallow pitched roof can often be a problem, originally because wind-driven rain could get underneath the slates. A problem that we have been coming across more recently is condensation can occur in the roof because there simply is not enough roof void for the dampness to dissipate.

Staining and dampness to the timbers beneath this roof.

ACTION REQUIRED: Add ventilation to the roof. At the same time the ridges should be checked of this roof and the main roof.

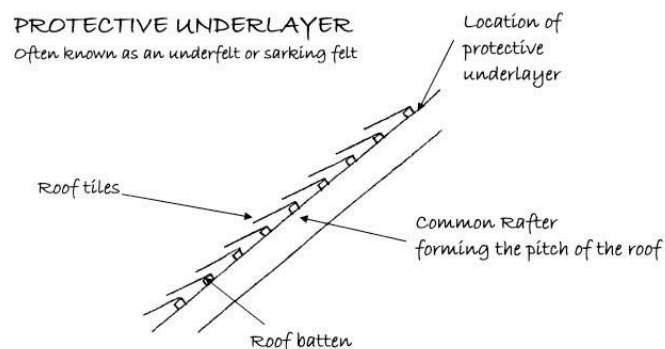
Main Roof

When we inspected the loft space we found there was no underfelt. It is therefore possible that during periods of heavy and prolonged driving rain some water penetration could take place through the roof coverings. At the time of our inspection this was not occurring.

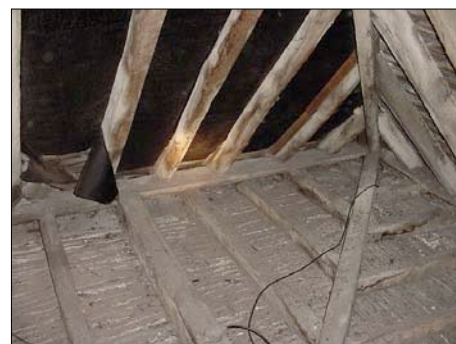
Main Roof to the right hand side, with underfelt

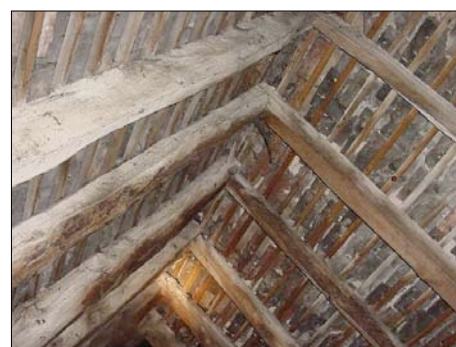
A close-up of the peg fixed ridge.

ACTION REQUIRED: Woodworm treatment may be required. We would need to re-inspect the roof in the breeding season (spring), and also some timber replacement may then be required.

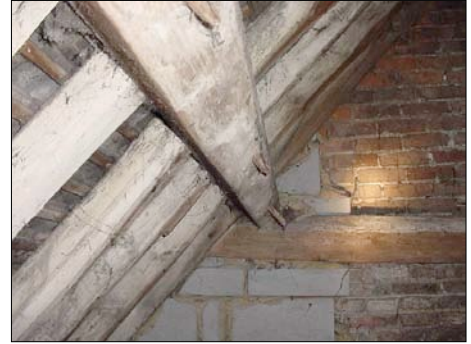
The purlin, and you can see some of the peg fixings.

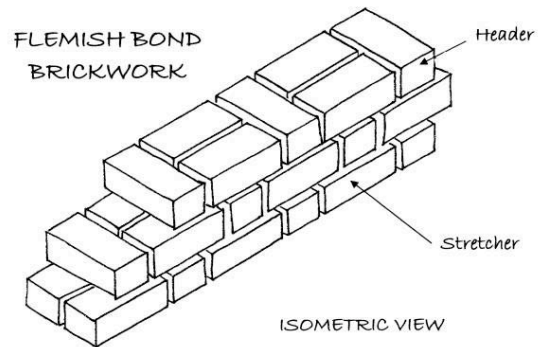
Taking into consideration the age, type and style of this property we would say that the brickwork and pointing overall is in below average condition.

ACTION REQUIRED: Likely to require ad hoc repointing, which should be carried out in a lime mortar.

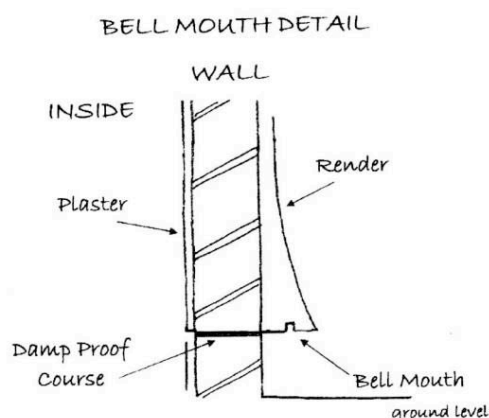
The render in this instance goes down to the ground. Unfortunately this will help dampness get into the structure.

ACTION REQUIRED: Form a bell-mouth to the base of the render.

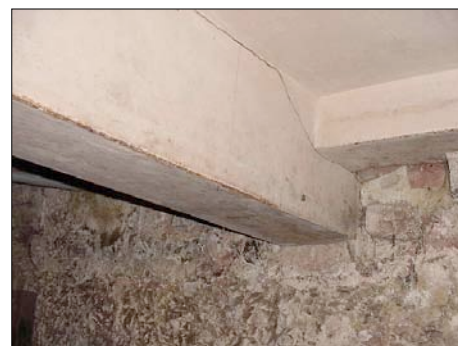
Plasterboard that has hidden the defects in the ceiling, but we can see already the plasterboard beads are rusting (this is because internal beads have been used rather than external, which are not resistant to dampness).

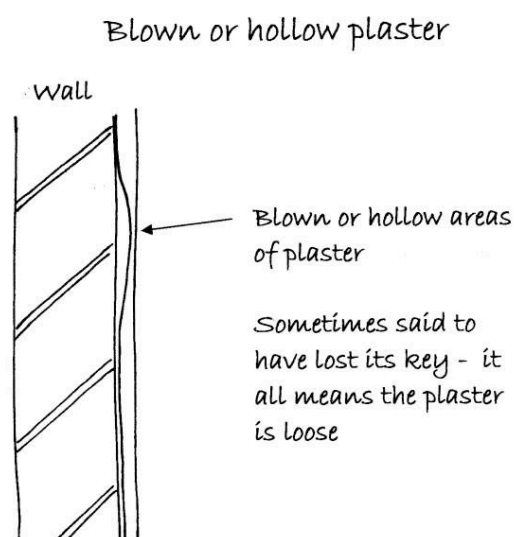
To the perimeter we found some areas of blown plaster. This is not uncommon in properties of this age, particularly around the window and door openings and around the chimney area. When redecorating you may have to do some re-plastering.

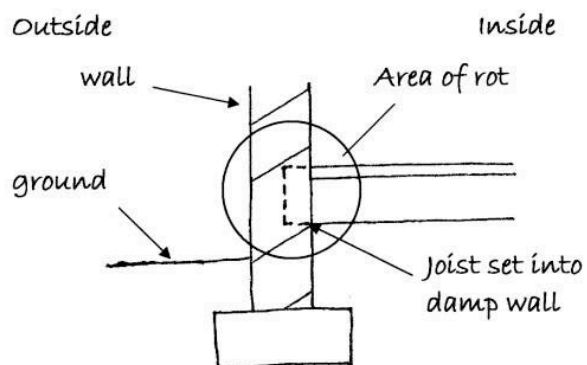
DAMP TO GROUND FLOOR JOISTS

No exposure was carried out due to the restrictions of fitted carpets, floor coverings etc. The comments are based upon our experience and knowledge of this type of construction.

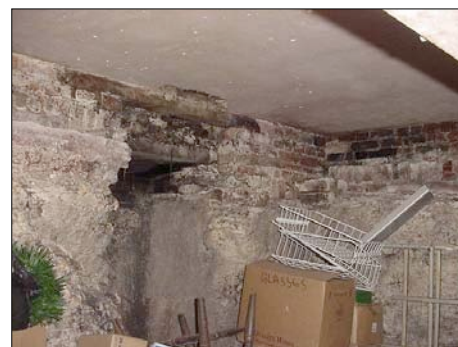
The cellar has been repaired over the years with both stone and brickwork. We feel that a missing factor in the cellar area is good ventilation.

Our view was very limited due to the recent replastering that has been carried out, although this itself is deteriorating already.

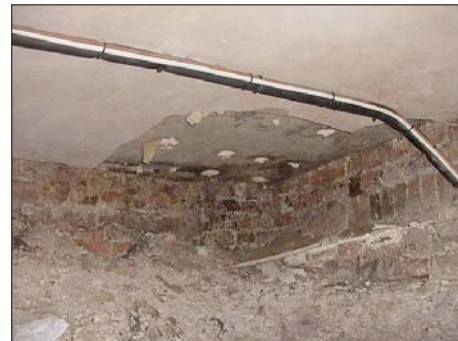
Storage Area

Finally, we have made a visual inspection of the cellar/vault only and have no way of knowing what the construction is without opening up the structure.

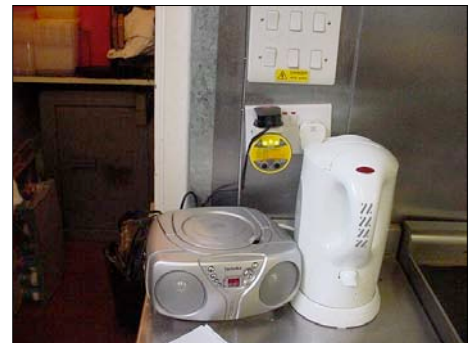
The electric fuses and consumer units were located in the lobby behind the bar. The fuse board looked dated.

We carried out an earth test in the kitchen area to the socket point that is normally used for the kettle, this proved satisfactory.

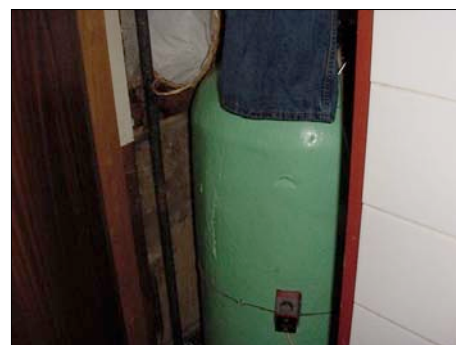
Hot Water Cylinder

The hot water cylinder is located in the bathroom. It is relatively new, as it is factory insulated.

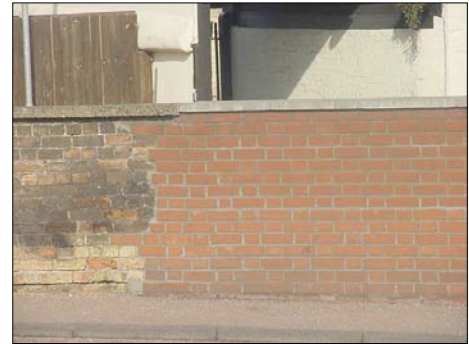
Rear Garden

We note that the boundary wall has been partly rebuilt. We also note that the original plaster wall has bonding timbers in it, indicating that it was likely once to form part of a building. Unfortunately, bonding timbers can rot over the years, which is maybe why the large portion of wall fell over when the car drove into the wall.

Here, if you look closely, you can see the bonding timbers in the wall.
