COMMERCIAL BUILDING SURVEY OF A Private 1960's Clubhouse

Mr A Client

GEM Associates Limited

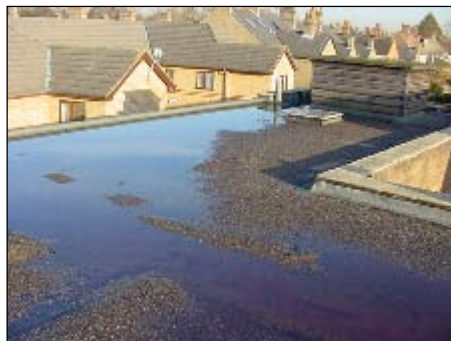
The Main Roof

The main roof is a flat bitumen roof that is leaking and has deflected. There was also ponding on the roof at the time of our inspection. We believe the best way to resolve the roof issues are to use an insulation cut to falls (to aim any rainwater at the outlets) and then to re-felt with a high performance elastomeric-type felt. The flashings will also need checking, as will the parapet walls in general.

General view of the roof

ACTION REQUIRED: The main roof needs re-roofing with falls adding to it, the lower roof can be patch repaired initially with future re-roofing and the lower right hand roof can also be patch repaired in the short-term.

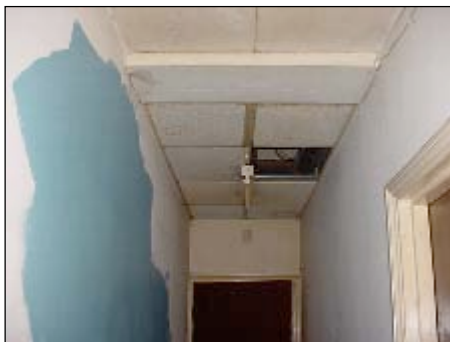
Lower Roofs

We were able to inspect the low level roofs through the suspended ceiling tiles, although our view was very limited. What we did see was what looked to be a wood decking, this looked to be damp in areas and we did note when walking on it that some areas were particularly spongy, indicating that water is getting through on to the decking itself.

This is the ceiling tile that we got in through to look at the ceiling.

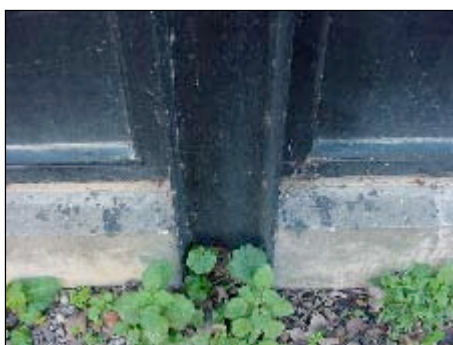
As the main structure is on the frame the areas between it should not be load bearing. The risk with this structure is due to the fact that the roof has been leaking for a while, which could have affected the framework and caused it to rust.

The base of one of the 'I' columns.

ACTION REQUIRED: We would ideally recommend that the structure is opened up, partly to the roof and partly at the base of the structure.

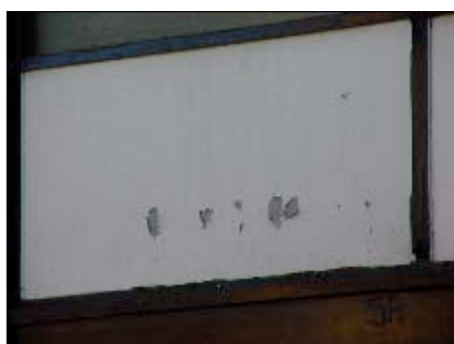
Profile Metal Cladding

An example of one of the metal cladding panels.

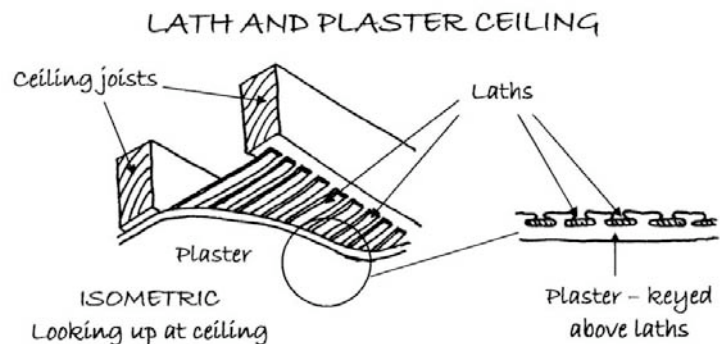
We have only been able to access the ceiling in the corridor area near the bar. Here there is a suspended ceiling system, this is usually attached via a wire suspension system to either the decking, the steel frame or timber joists. As a general comment there is damage to some of the ceilings, for example to the first floor bar area there is water damage, where the water has literally come through the roof, and there are tiles damaged and missing to the suspended ceiling system on the ground floor.

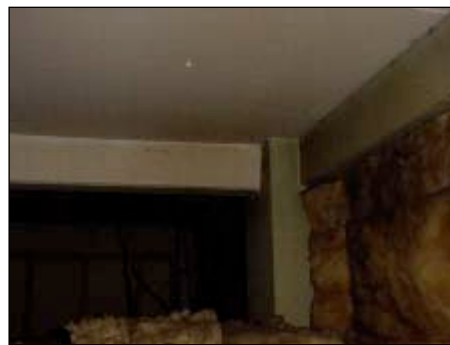
This is a further photo in the roof section which indicates to us that there is a beam and collar structure to the single storey part of the property,

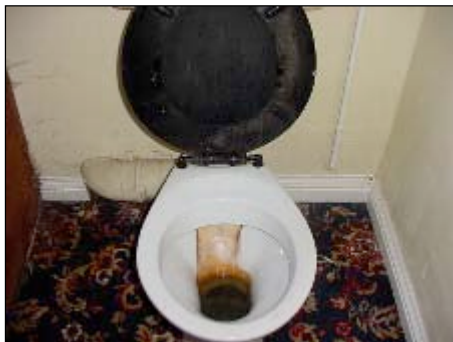
We would describe the ground floor sanitary fittings as well used and abused and the first floor sanitary fittings as in need of some work. To be fair we were only able to access the female toilet on the first floor and we did manage to get the w.c. to flush and the taps to run and a general clear up, together with some ad hoc repairs such as replacing the handle on the w.c. for example, may well be sufficient

First floor ladies W.C.

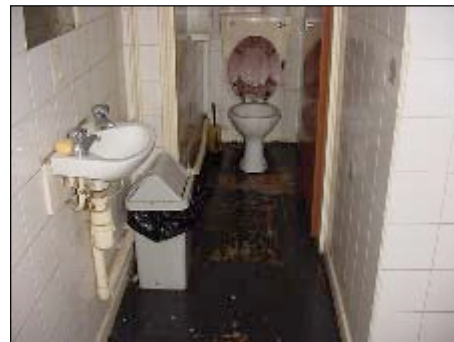
Gents W.C.

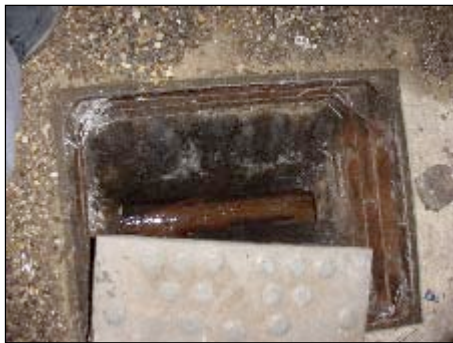
There were also some further manholes that we could not get open. One of which looked to have been rusted in place.

A view of the manhole, you can see the brickwork, which means it is traditionally built.
