SCHEDULE OF CONDITION

XXXXXX Amersham, Bucks. XXXXXXXX.

INDEPENDENT CHARTERED SURVEYORS

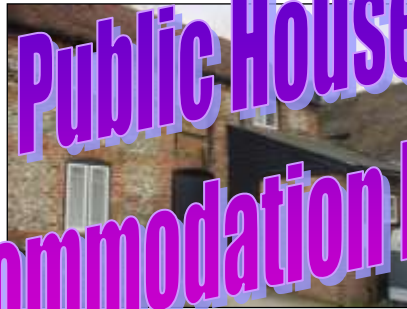
ACCOMMODATION - FRONT ELEVATION

Front elevation

DESCRIPTION	CONDITION	ACTION REQUIRED
Roofs: Pitched clay tiles	Missing and damaged tiles	Overhaul roof
Gutters and Downpipes: Cast iron	Areas of the gutters are rusting, leaking and out of alignment	Ensure all gutters are watertight and falling towards the downpipe. Repair and secure as necessary, ensure downpipes are clear.
Walls: Brick with flint infill and some old timber beams	Cement mortar has been used rather than a lime mortar and needs to be replaced.	Repair, prepare and repoint using lime mortar.
Windows: Single glazed timber with leaded lights	Wet rot and deteriorating paintwork	Repair, prepare and redecorate.

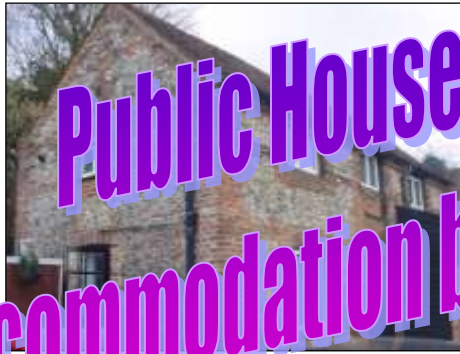
ACCOMMODATION – LEFT HAND GABLE END ELEVATION

Left hand elevation

DESCRIPTION	CONDITION	ACTION REQUIRED
<p>Walls: Brick with flint infill and some old timber beams</p>	<p>Where flashing meets the adjacent kitchen it needs repair. Cement mortar has been used rather than a lime mortar and needs to be replaced.</p>	<p>Repair, prepare and repoint using lime mortar.</p>
<p>Windows: Single glazed timber with leaded lights</p>	<p>Wet rot and deteriorating paintwork</p>	<p>Repair, prepare and redecorate.</p>

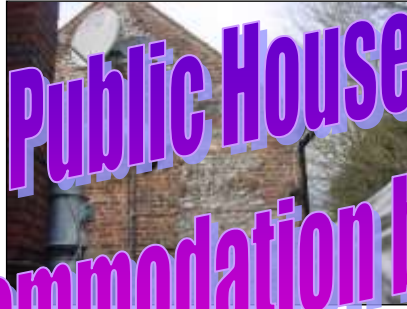
ACCOMMODATION - RIGHT HAND GABLE END ELEVATION

Right hand elevation

DESCRIPTION	CONDITION	ACTION REQUIRED
<p>Walls: Brick with flint infill and some old timber beams</p>	<p>Where flashing meets the adjacent kitchen it needs repair. Cement mortar has been used rather than a lime mortar and needs to be replaced.</p>	<p>Repair, prepare and repoint using lime mortar.</p>
<p>Windows: An old window has been bricked up.</p>

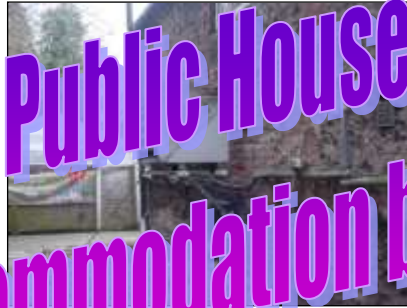
ACCOMMODATION - REAR ELEVATION

Accommodation block
Rear elevation

DESCRIPTION	CONDITION	ACTION REQUIRED
Roofs: Pitched clay tiles	Missing and damaged tiles	Overhaul roof
Gutters and Downpipes: Cast iron	Areas of the gutters are rusting, leaking and out of alignment	Ensure all gutters are watertight and falling towards the downpipe. Repair and secure as necessary, ensure downpipes are clear.
Walls: Predominately flint with brick and some old timber beams. Tie-bar to first floor level.	Major cracks Cement mortar has been used rather than a lime mortar and needs to be replaced.	Repair, prepare and repoint using lime mortar.

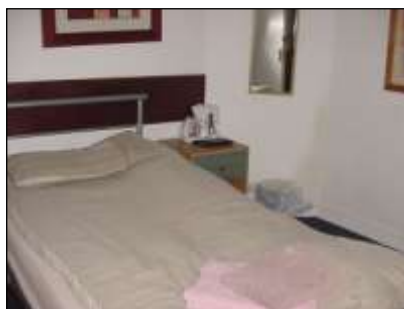
Bedroom One

DESCRIPTION	CONDITION	ACTION REQUIRED
Ceilings: Painted with timber beams	Dated	Repair, prepare and redecorate.
Walls: Painted plasterboard	Dated Rising damp and lateral damp coming in	Resolve damp issues and repair, prepare and redecorate.
Floors: Solid under foot and carpeted		Clean or replace
Joinery: Windows: Doors:	See External comments Some marks	Repair, prepare and redecorate. Clean, repair, prepare and redecorate.

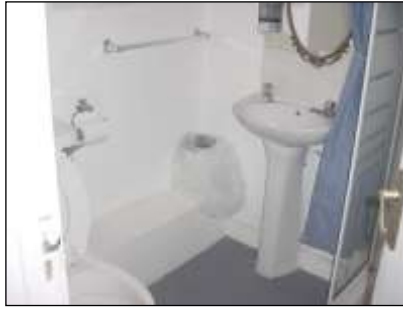
Bedroom One en suite shower room

En suite Bedroom One

DESCRIPTION	CONDITION	ACTION REQUIRED
Ceilings: Plaster with some timber, partly formed under staircase so ceiling is angled	Dated	Repair, prepare and redecorate.
Walls: Painted	Dated	Repair, prepare and redecorate.
Floors: Vinyl		Check and re mastic seals
Sanitary Ware: Shower	Dated Timber within shower is rotting	Deep clean and re-grout shower tiles, replace rotting timber

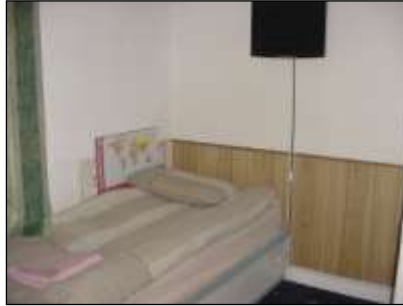
First Floor**Bedroom Two (front left hand side)**

Bedroom Two

DESCRIPTION	CONDITION	ACTION REQUIRED
Ceilings: Painted plaster	Dated	Repair, prepare and redecorate.
Walls: Painted plaster Timber wall plates	Dated	Repair, prepare and redecorate.
Floors: Carpet		Clean or replace
Joinery: Windows:	See previous comments in External section	Repair, prepare and redecorate.
Door:	Marked	Repair, prepare and redecorate.

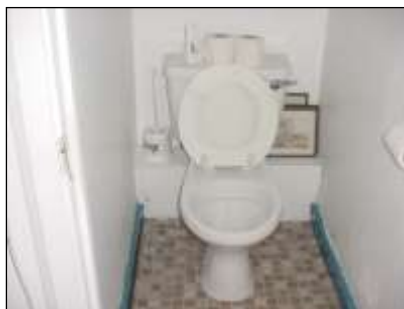
Bedroom Two en suite shower room (middle)

En suite to Bedroom Two

DESCRIPTION	CONDITION	ACTION REQUIRED
Ceilings: Painted plaster	Dampness	Repair, prepare and redecorate.
Walls: Painted plaster Extract fans	Dampness	Repair, prepare and redecorate.
Floors: Vinyl		Check the mastic
Joinery: Door	Marked	Repair, prepare and redecorate.
Sanitary Ware: Shower, WC and wash hand basin	Dated	Deep clean
Services: See Services section

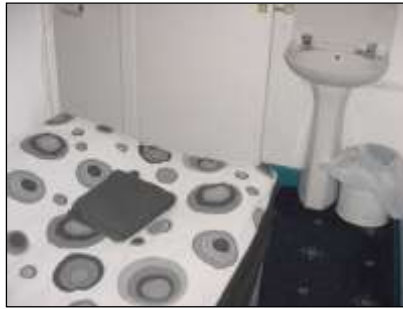
Bedroom Three (front right hand side)
Double bedroom plus a single bed

Bedroom Three

DESCRIPTION	CONDITION	ACTION REQUIRED
Ceilings: Painted plaster	Dated	Repair, prepare and redecorate.
Walls: Painted plaster Timber wall plate running round the top	Dated	Repair, prepare and redecorate.
Floors: Carpet		Clean or replace
Joinery: Windows:	Refer to our comments in the External section	Repair, prepare and redecorate.
Services: See Services section

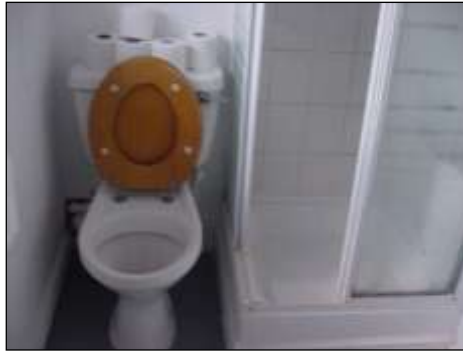
Bedroom Three en suite shower and wash hand basin

En suite to Bedroom Three

DESCRIPTION	CONDITION	ACTION REQUIRED
Ceilings: Painted plaster	Dated	Repair, prepare and redecorate.
Walls: Painted plaster Timber wall plate	Dated	Repair, prepare and redecorate.
Floors: Vinyl		Renew mastic seals
Sanitary Ware: Shower and wash hand basin Tiled	Dated Needs re-grouting	Deep clean and re-grout
Services: See Services section

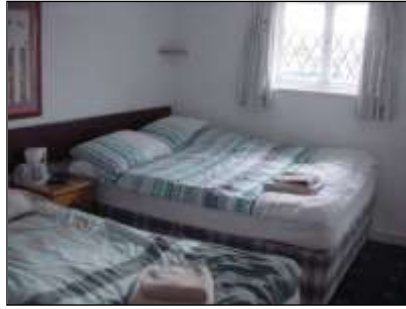
Bedroom Four

DESCRIPTION	CONDITION	ACTION REQUIRED
Ceilings: Painted plaster	Dated	Repair, prepare and redecorate.
Walls: Painted plaster	Dated	Repair, prepare and redecorate.
Floors: Carpet		Clean or replace
Joinery: Windows:	Refer to our comments in the external section	Repair, prepare and redecorate.
Services: See Services section

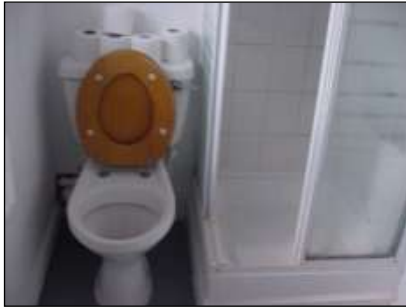
Bedroom Four en suite WC

En suite to Bedroom Four

DESCRIPTION	CONDITION	ACTION REQUIRED
Ceilings: Painted plaster Extract fan	Dated and mould on plaster Dirty	Repair, prepare and redecorate. Clean
Walls: Painted plaster Timbers to top of the wall	Dated and mould on plaster	Repair, prepare and redecorate.
Floors: Vinyl		
Sanitary Ware:	Dated	Deep clean
Services: See Services section

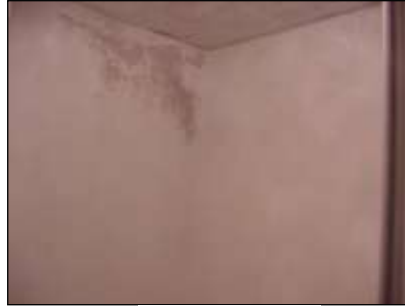
Mould
