SCHEDULE OF CONDITION

XXX Amersham, Bucks. XXX

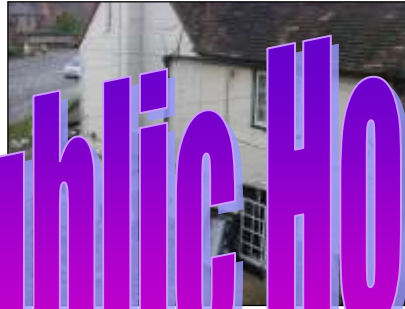
PUBLIC HOUSE RIGHT HAND GABLE END ELEVATION

DESCRIPTION	CONDITION	ACTION REQUIRED
Chimneys: One brick chimney		See comments to the front elevation
Roofs:		
Gutters and Downpipes: Predominately cast iron Cooling unit:	Rusting in need of repair	Ensure all gutters are watertight and falling towards the downpipe. Repair and secure as necessary, ensure downpipes are clear.
Walls: Painted brickwork	Damp walls In need of a French drain	Repair, prepare and repoint using lime mortar. Add a French drain
Windows: Two casement windows		Repair, prepare and redecorate.

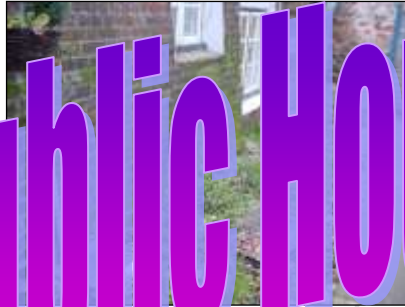
PUBLIC HOUSE REAR ELEVATION

Rear elevation

DESCRIPTION	CONDITION	ACTION REQUIRED
Chimneys: One Brick chimney	Cracked and needs repointing	Repoint and make watertight, check flashings
Roofs: Three pitched roofs clay tiled with awkward valley gutters Slate roof over kitchen area		Overhaul repair and make watertight Overhaul repair and make watertight
Gutters and Downpipes: Cast iron and plastic Soil and vent pipe: Plastic		Ensure all gutters are watertight and falling towards the downpipe. Repair and secure as necessary, ensure downpipes are clear.

Walls: Brickwork	Damp Covered with moss and step out slightly to the rear	Add French gully Clear moss and repoint in an appropriate mortar
Windows: Casement and York	Deteriorating	Repair, prepare and redecorate.

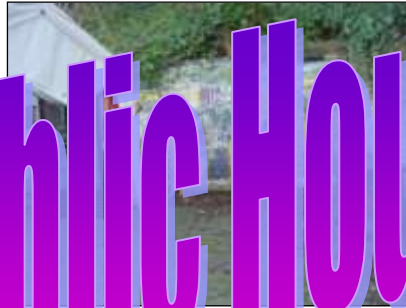
OUTSIDE AREAS

Concrete retaining wall and paved area

DESCRIPTION	CONDITION	ACTION REQUIRED
Concrete retaining wall approx 5m away that does not have any drainage system on it.	Needs repointing	Repoint and add weep holes
Car Park	Deteriorating with pot holes	Overhaul filling pot holes and adding white lines

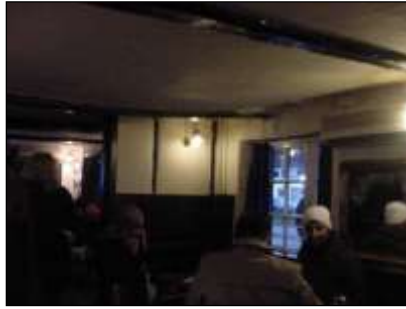
Main L-shaped Bar and associated servery

L-shaped bar

DESCRIPTION	CONDITION	ACTION REQUIRED
Ceilings: Painted with timber beams	Dated	Repair, prepare and redecorate.
Walls: Painted with timber beams	Dated	Repair, prepare and redecorate.
Floors: Carpets		Clean and/or replace
Joinery: Windows Doors	See comments in External section See comments in External section	Repair, prepare and redecorate. Repair, prepare and redecorate.

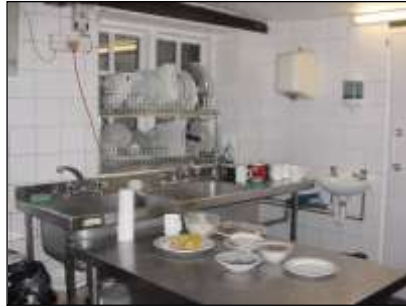
Catering Kitchen

DESCRIPTION	CONDITION	ACTION REQUIRED
Ceilings: Painted	Dirty and marked	Repair, prepare and redecorate.
Walls: Tiled	Damp Some marking holes and dirt	Deep clean and make good
Floors: Vinyl style	Does not look to be a safety floor	Replace with a safety floor
Joinery: Windows Doors	See external section comments	Repair, prepare and redecorate. Repair, prepare and redecorate.
Catering Equipment: The catering equipment has not been inspected, as we are not expert in this area, you should seek expert advice. We have assumed that the catering equipment meets Local Authority approval and is appropriate for use.

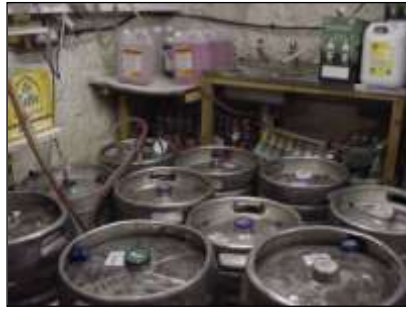
Cellar

DESCRIPTION	CONDITION	ACTION REQUIRED
Ceilings: Painted	Dated	Repair, prepare and redecorate.
Walls: Painted	Dated	Repair, prepare and redecorate.
Floors: Concrete		Make good the floor
Joinery: Doors	Marked	Repair, prepare and redecorate.

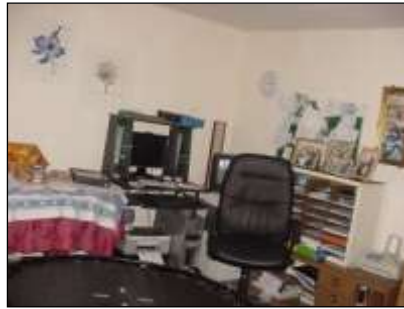
Lounge (front left hand side)

Lounge

DESCRIPTION	CONDITION	ACTION REQUIRED
Ceilings: Painted with spine beam	Woodworm to spine beam	Repair, prepare and redecorate.
Walls: Painted Timber beams	Racking crack to rear right hand corner Newly decorated maybe hiding latent defects	Repair, prepare and redecorate.
Floors: Timber floor with carpet	Deflects	Need to open up the floor to examine timbers
Joinery: Windows:	See previous comments in external section	Repair, prepare and redecorate.

Note there is deflection in this room and the adjoining access corridor, the floor structure needs opening up and checking

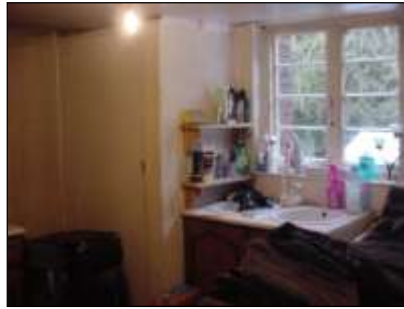
Rear left hand side Kitchen/Laundry Room

Kitchen/Laundry room

DESCRIPTION	CONDITION	ACTION REQUIRED
Ceilings: Painted Smoke detector: hardwired into system	Dated	Repair, prepare and redecorate.
Walls: Wall papered	Dated Cracking to rear right hand side wall indicating that there is movement in the property	Repair, prepare and redecorate.
Floors: Carpet	Deflecting	Need to open up to examine the floor
Joinery: Window: Casement	In need of repair and redecoration (gap)	Repair, prepare and redecorate.
Sanitary ware: Double bowl and sink to rear window	Basic	Upgrade recommended

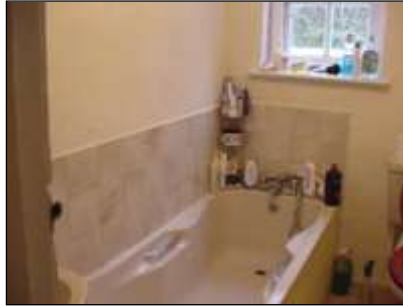
Bathroom to rear

Bathroom

DESCRIPTION	CONDITION	ACTION REQUIRED
Ceilings: Lath and plaster Painted	Heavy cracking	Repair, prepare and redecorate.
Walls: Painted and tiled around the bath	Damp	
Floors: Carpet	Dirty	Deep clean
Joinery: Windows: Doors:	Please see the thermal schedule of condition	Repair, prepare and redecorate. Repair, prepare and redecorate.
Sanitary Ware: Bath, wash hand basin and WC		Deep clean

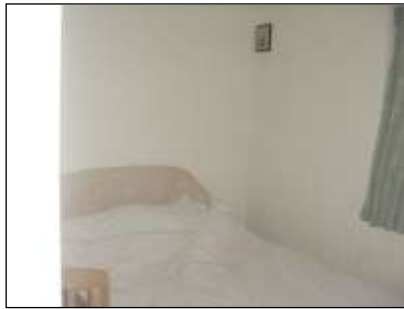
Bedroom One rear right hand corner

Bedroom One

DESCRIPTION	CONDITION	ACTION REQUIRED
Ceilings: Painted	Some undulations Dated	Repair, prepare and redecorate.
Walls: Painted	Dated	Repair, prepare and redecorate.
Floors: Timber covered with carpet	Uneven floor	Refer to previous comments with regard to floor in general.
Joinery: Window: Casement Built in cupboard	Allowing dampness in and rotting as seen from outside Deflection shown in property for some time

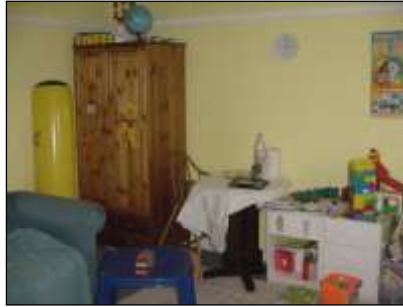
Bedroom Two front right hand side

Bedroom Two

DESCRIPTION	CONDITION	ACTION REQUIRED
Ceilings: Painted with feature timbers and spine beam	Dated Signs of some woodworm Undulating	Repair, prepare and redecorate.
Walls: Painted Picture rail	Dated Undulating	Repair, prepare and redecorate.
Floors:	Uneven floor	Refer to previous comments with regard to floor in general.
Joinery: Windows: Casement Doors: Painted ledge and brace	Allowing damp in Out of square	
Services: Radiator – internal underneath the window

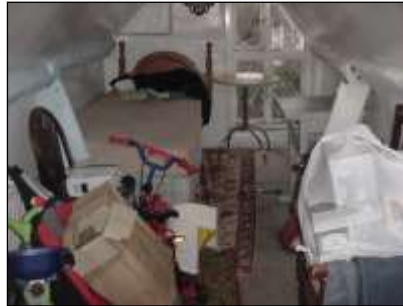
Room within roof space divided into two right hand side

Room within roof space right side

DESCRIPTION	CONDITION	ACTION REQUIRED
Ceilings: Gloss painted vaulted	Dated	Repair, prepare and redecorate.
Walls: Painted	Dampness coming in around the chimney at the gable end	Repair, prepare and redecorate.
Floors Carpet		Clean or replace
Joinery: Windows: one single glazed casement window to gable end Staircase:	Signs of woodworm and cracking to the timber which is slightly soft	Repair, prepare and redecorate.
Services: See Services section Radiator

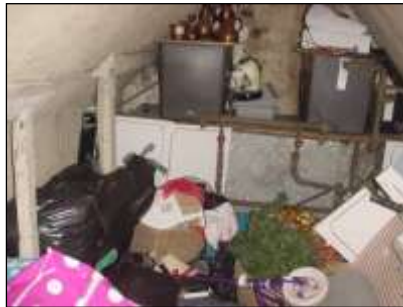
Room within roof space store/junk room left hand side

Room within roof space left side

DESCRIPTION	CONDITION	ACTION REQUIRED
Ceilings: Unfinished fibre board		
Walls: Unfinished fibre board		
Floors: Boarded		
Joinery: Access hatch to rear	Dampness in timber	Repair, prepare and redecorate.
Services: See Services section Water tanks to gable end

Limited view due to stored items in this area
