RESIDENTIAL BUILDING SURVEY

London Borough of Enfield

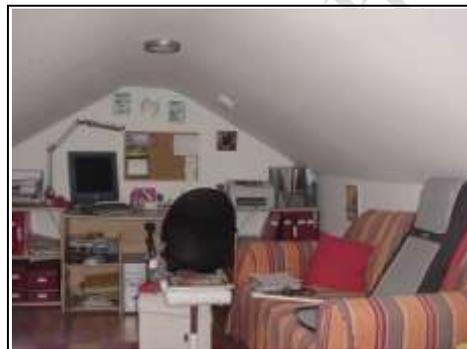
We were slightly concerned by what we saw as typically with a room in the roof there would be a requirement for increased fire regulation safety by adding a hard wired fire alarm system throughout the building and possibly putting an entrance door onto the area, the increasing of ceiling joists to floor joist size and the adding of insulation in the roof to stop thermal loss during the winter and thermal gain during the summer. The staircase blocks over the access into the roof which concerns us that the stairs may have been added at a later date and may not have been approved by the Local Authority who have to approval staircases.

Room in roof

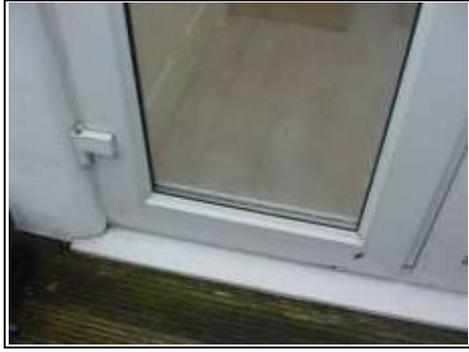
We noted in the bathroom that the extract fan didn't extract very well (we carried out a basic test by putting a piece of paper to the extract). In the kitchen we didn't note any extract to external air. The utility room in the rear extension didn't look to have an extract either.

Condensation on utility room door

ACTION REQUIRED: Add large humidity controlled extract fans and check and open vents as necessary. Add trickle vents to windows if possible.

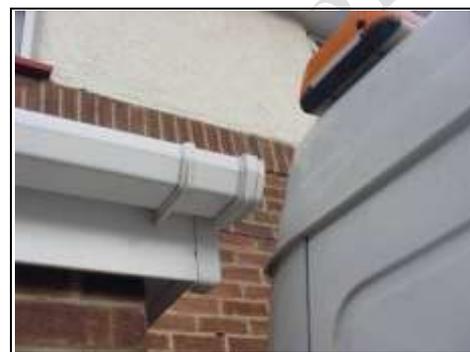
The property has profile plastic gutters and downpipes, these looked relatively new. We believe they were carried out when the fascias and soffit work was carried out.

There may be some minor leaks but most people would be happy to live with these providing repairs are carried out within the next six to twelve months.

ACTION REQUIRED: We would always recommend you stand outside the property next time it rains heavily and see how well the drains cope with the rainwater particularly looking at the guttering and the joints.

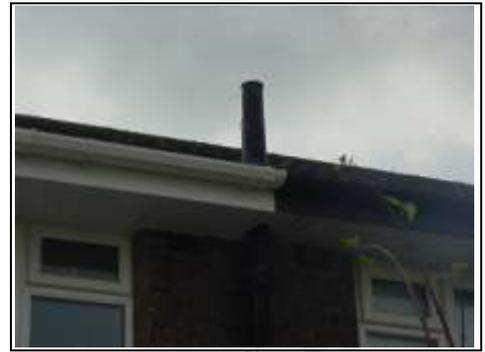
Cast iron soil and vent pipe

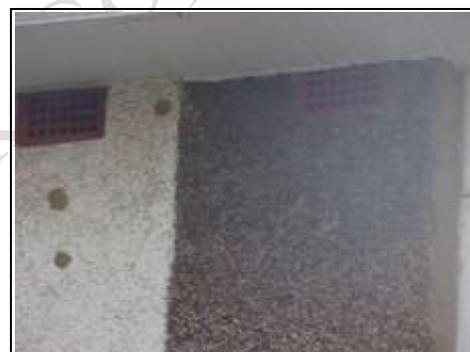
To the rear the external walls are finished in a relatively smooth faced painted render.

Render to rear

ACTION REQUIRED: The render would benefit from redecoration in the summer of 2013.

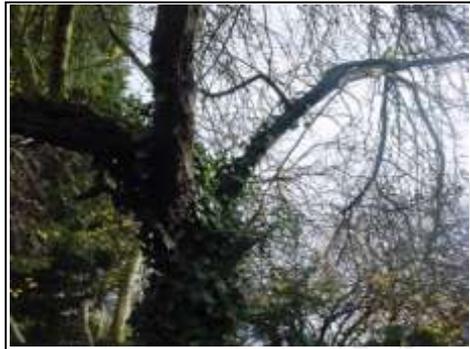
Trees to rear

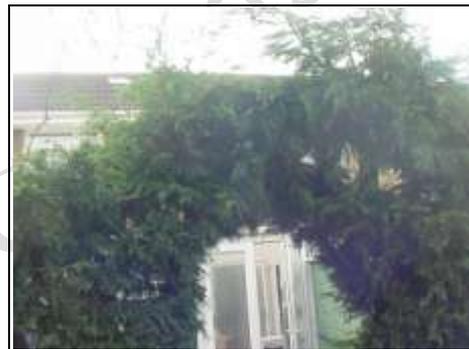
Arch in conifers

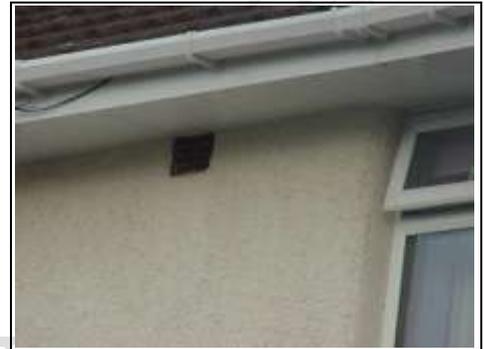
There are vents at high level which we believe were blocked. These need to be checked.

Air brick to front

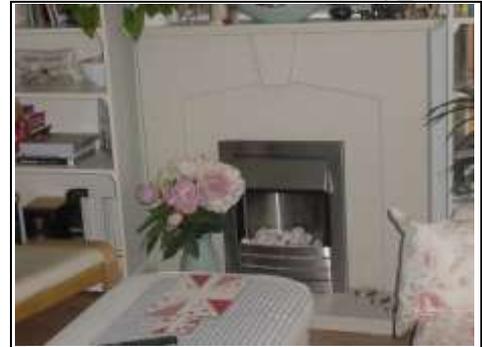
Fireplace in front lounge

It is strongly recommended that flues be cleaned and checked for obstructions prior to use to minimise the risk of hazardous fumes entering the building.

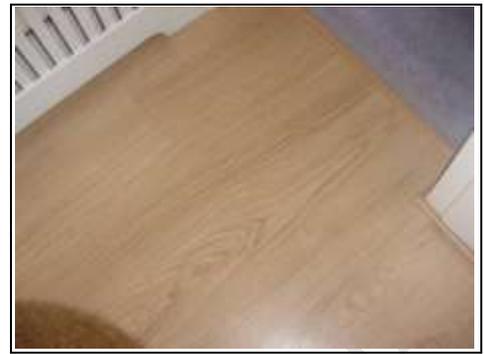
Laminate floor and carpet

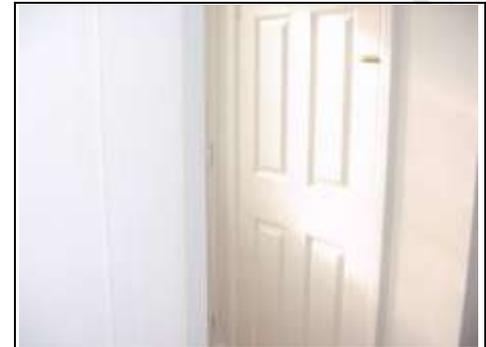
The doors are hollow core doors.

Typical door

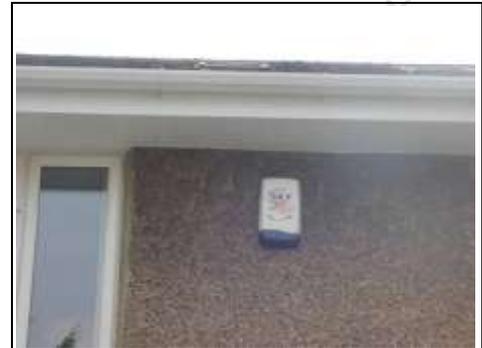
Alarm

A security system has been installed. A good alarm system should not only help reduce break-ins but also your insurance. We are not experts in this field and therefore cannot comment further.

ACTION REQUIRED: Further information should be obtained from the vendor and the installer at a later date.

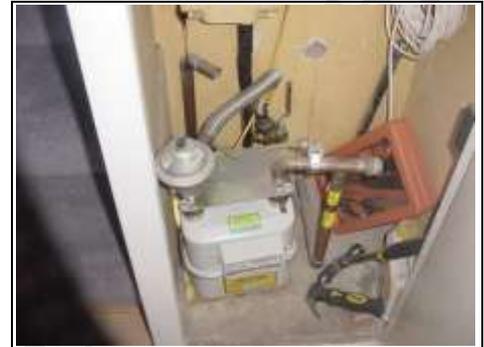
We are advised that the property has mains gas. The owner didn't know the location of the gas consumer unit.

ACTION REQUIRED: As a matter of course it is recommended that the entire gas installation is inspected and made good, as necessary, by a Gas Safe registered contractor. Thereafter the installation should be serviced annually.

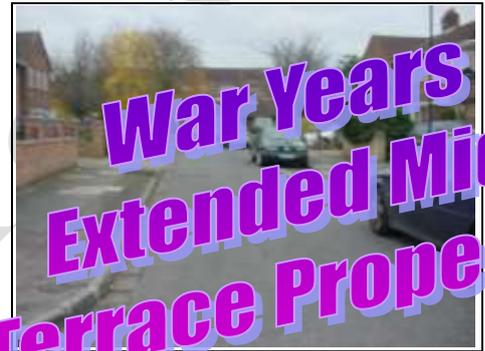
The front garden has been given over to parking. There does look like there will be problems on parking in the area; we had to park away from the property (rather than in front of it) at the time of the survey as I believe you did as well.

Problems with parking

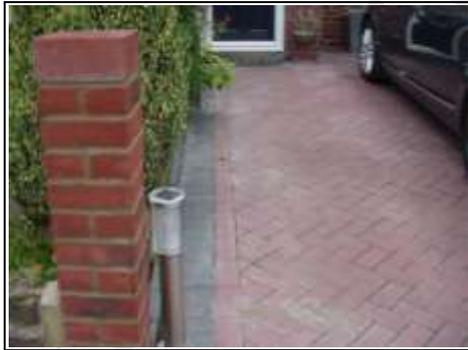
We were shown a receipt dated 26/07/2011 for the driveway and garden wall.

Parking to front

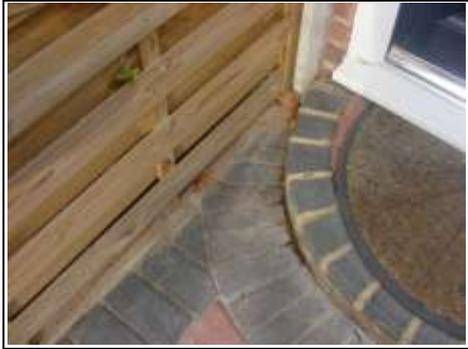
Brick paving

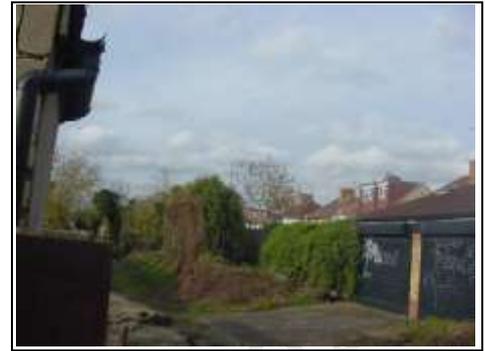
Access to rear of property.
Photo taken over fence, we
didn't access it.

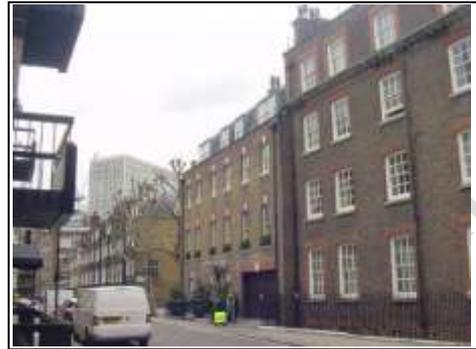
Older style London converted flats with property problems such as Condensation and Cold Bridging

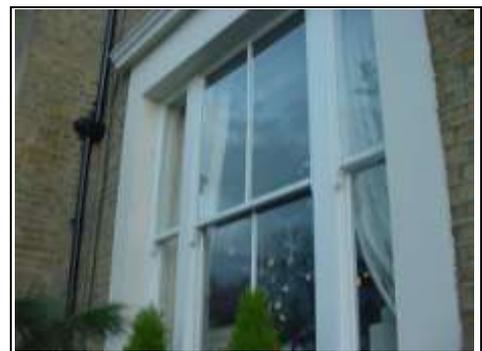
Sliding sash windows can swell in the winter months
