RESIDENTIAL BUILDING SURVEY

**Hemel Hempstead,
Hertfordshire
HP2**

INDEPENDENT CHARTERED SURVEYORS

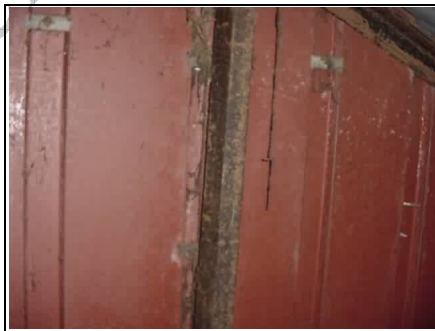
Square metal tube that we believe forms part of the metal frame the whole building

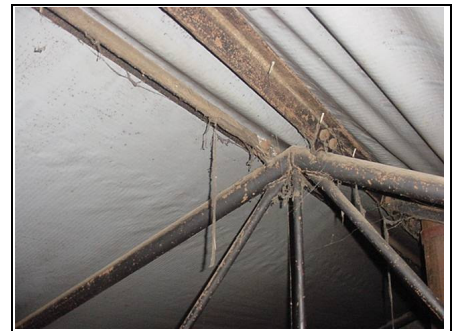
Metal tubular truss that forms the roof

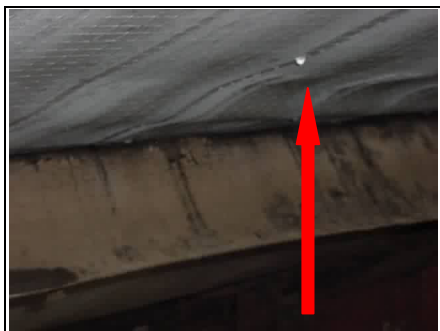
During the course of the survey we were particularly concerned to see the condensation in the roof; literally water condensation running down the plastic protective underlayer. We would also recommend ensuring the vents in the roof give an air flow to the roof space. However, ideally the property should be re-roofed with a standard tile and a modern breathable protective underlayer and unfortunately the plastic underlayer that you presently have is helping to promote condensation in the property.

Close up of white condensation globules

ACTION REQUIRED: We would recommend that as soon as possible the air vents are opened up in the roof to allow an air flow and add an air vent at the ridge.

ANTICIPATED COST: In the region of £1,500 to £4,000 as this is high level work and may well need scaffolding; please obtain quotations.

We would add that we feel the only real long term solution to this is to re-roof the property and use a breathable underlayer. Ideally we would like the tin roof to be removed but then careful consideration has to be given as to what sort of roofing material to change it to due to weight and other considerations.

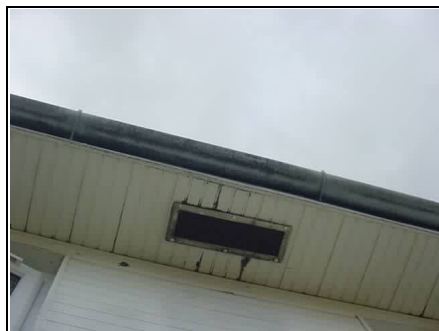
Vent on soffit board

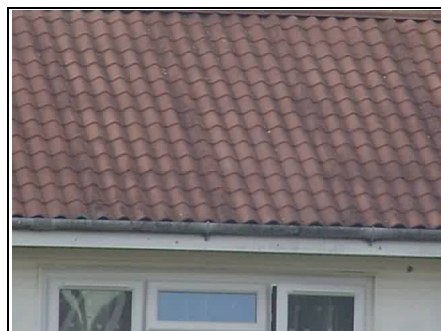
Tin roof

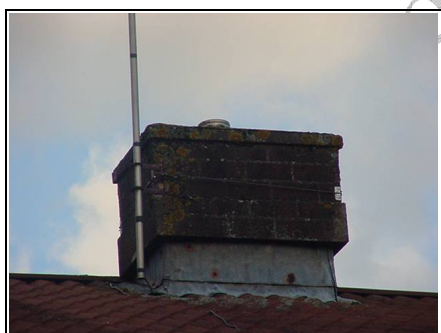
There is one chimney, located to the front middle left hand side of the property. The chimney is a mock brick chimney which we believe is timber clad with a render finish on to a metal frame. We have spoken to Dacorum Borough Council informally who advise that it was part of a refurbishment programme in 1985/1986. It looks to have to a lead flashing to the base, although we can see that the screws are rusting.

Mock brick chimney

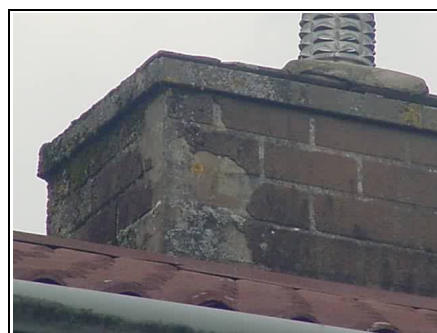
Photo of a nearby chimney where the mock brick facing has come away

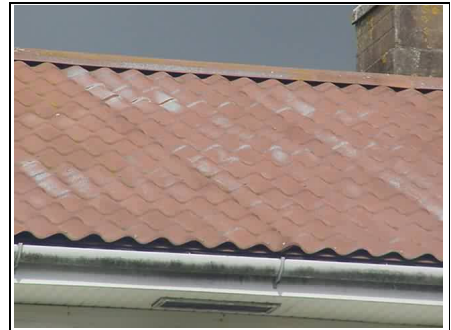
We can see weathering on a nearby roof

ACTION REQUIRED: Your solicitor needs to get confirmation from the council that all the asbestos has been removed and that they have an up to date asbestos certificate for the property.

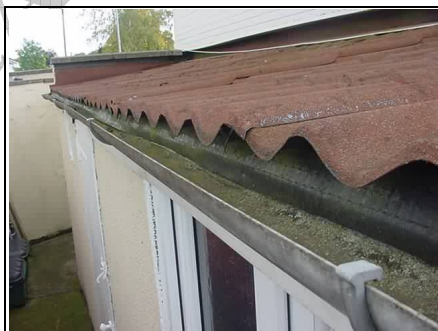
There is a single storey roof over the storage area to the front right hand side (all directions given from the front) is a shallow pitched metal roof similar to the main roof. You did allow us to have a close look at this and we could see that it had been riveted together.

Close up of metal tiles

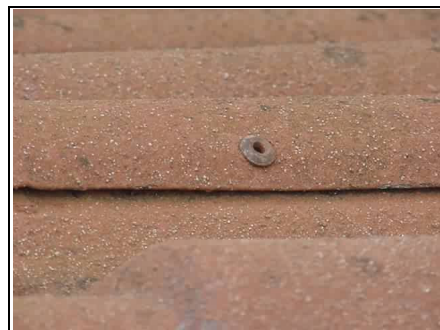
Fixing rivets

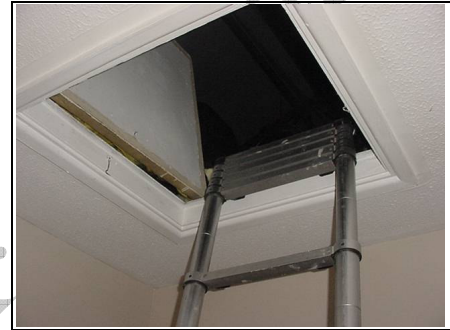
Loft hatch

There is no loft ladder, electric light or secured floorboards. We recommend that these be added, as it will make the loft space safer and easier to use.

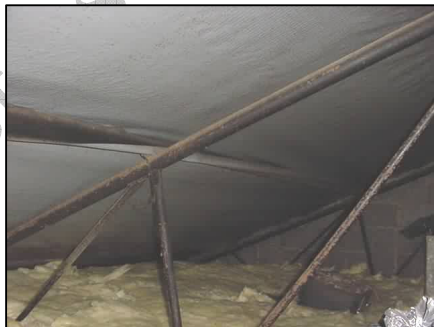
Middle of metal roof truss

Our examination was limited by the general configuration of the roof and the mass of insulation. We generally found the roof truss to be in average to below average condition; it is suffering from rust, which in turn puts in question its long term life particularly considering the condensation that was within the roof.

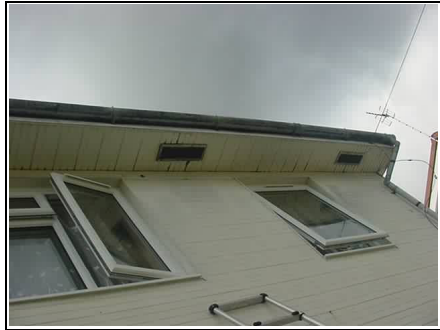
There are vents to the soffits, however these vents look to be blocked by the mass of insulation.

Vents in the soffits

ACTION REQUIRED: We would recommend vents at high level/the ridge. Please see our comments in the Executive.

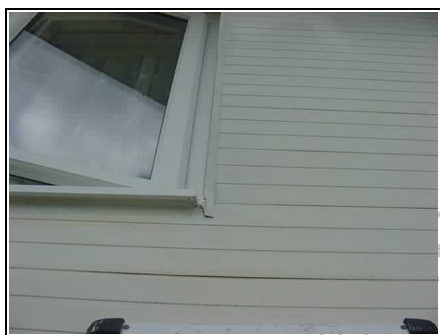
The external of the property is clad with plastic cladding to the first floor level. There is likely to be a profile metal sheet beneath this. Internally there appears to be plasterboard but this could equally be a proprietary boarding and we would bring to your attention that properties of this era often had asbestos within their structure.

Cladding to first floor level

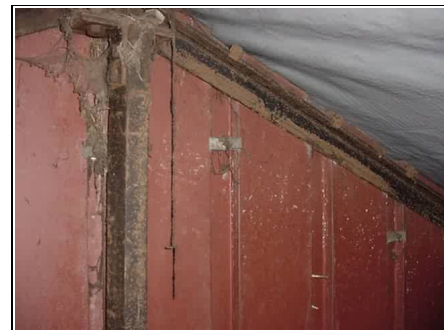
We can see the structural frame within the roof (limited view). Our concern is that the structural frame is rusting throughout due to the amount of condensation in the property over the years (which is very difficult to avoid with this type of property).

Vertical structural tube to ridge of roof

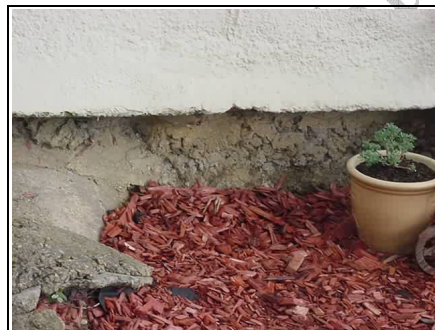
All modern properties should incorporate a damp proof course (DPC) and good building practice dictates that a differential of 150mm (6 inches) should be maintained between the damp proof course and ground levels. In this case we cannot see a DPC because of the render.

DPC not visible due to render

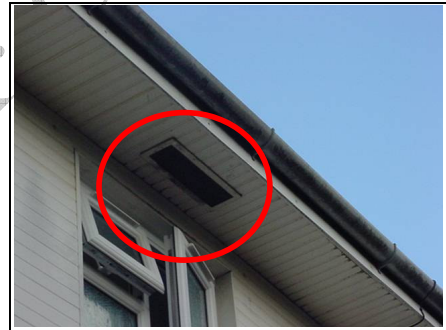
The fascias and soffits look to be a plastic cladding, although we would advise that beneath this we have in the past found asbestos and similar. We would comment they are in average condition for their age, type and style.

Soffit with vent

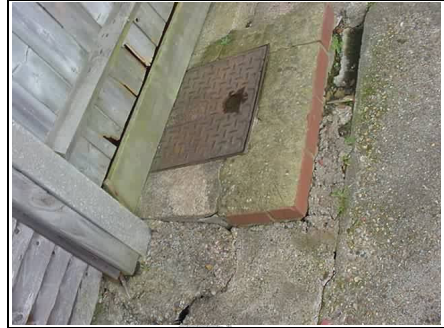
We were unable to lift this manhole due to the fence. Often in Local Authority built estates, or equivalent, you do have drains in awkward places.

Manhole partly under the fence

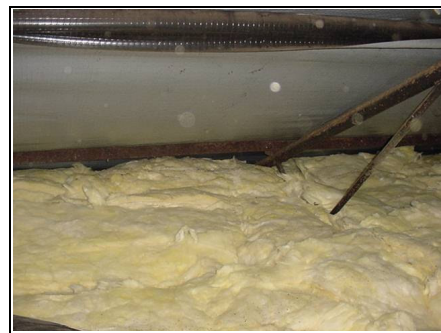
Mass of insulation in roof space

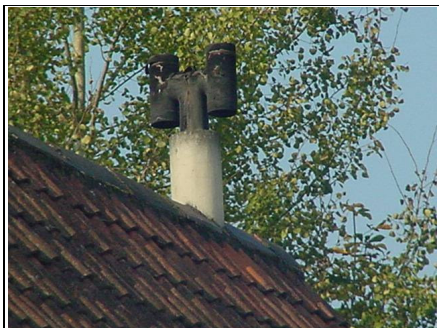
Asbestos flue

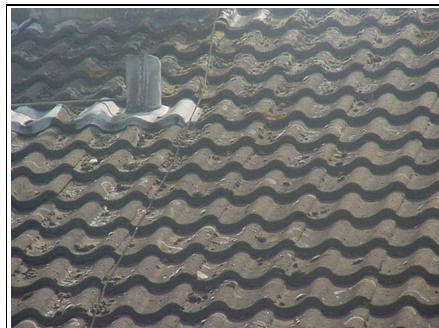
Asbestos flue

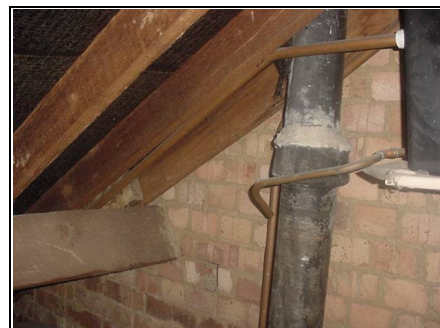
Asbestos flue within roof space

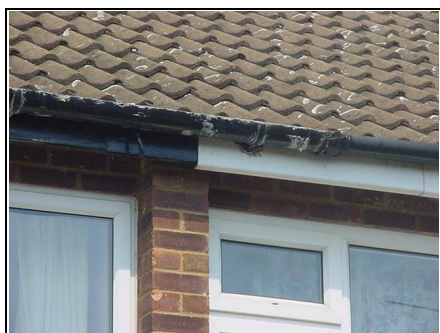
Asbestos gutter, is that an asbestos fascia board?

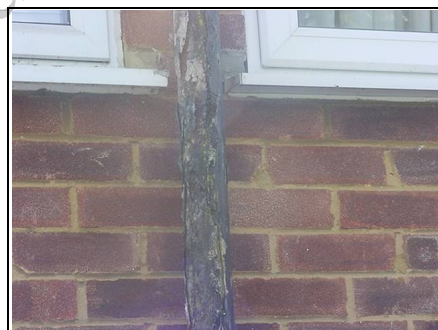
Asbestos downpipe to rear

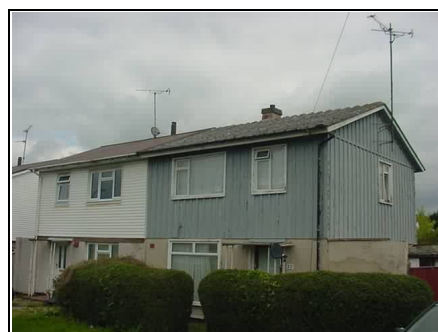
Asbestos roof on non-traditional property

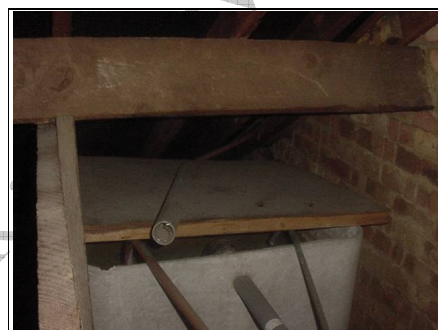
Asbestos water tank

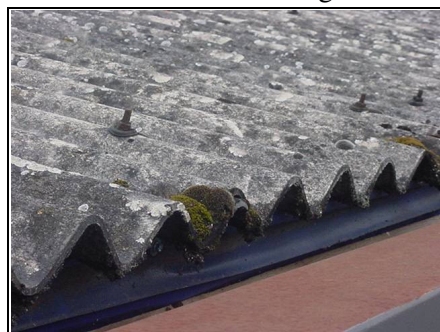
Asbestos roof

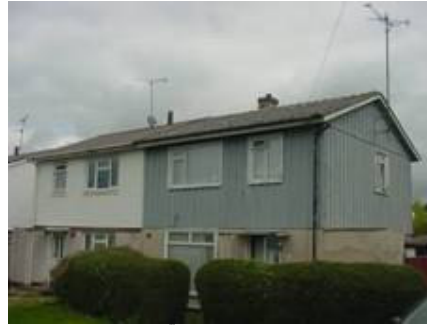
Asbestos roof on BISF house

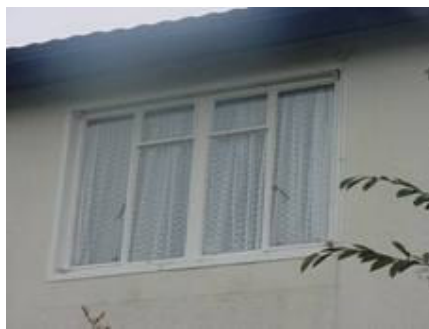
Close up of old metal windows in a non-traditional house

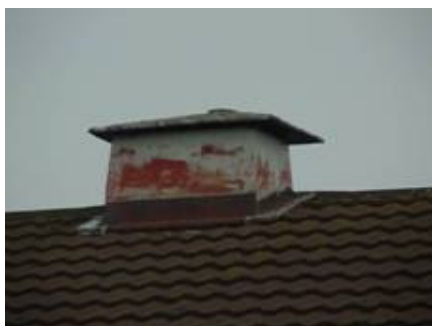
Asbestos original chimney non traditional house

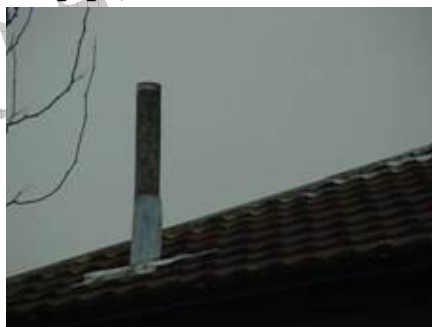
Original asbestos soil and vent pipe on a non-traditional house

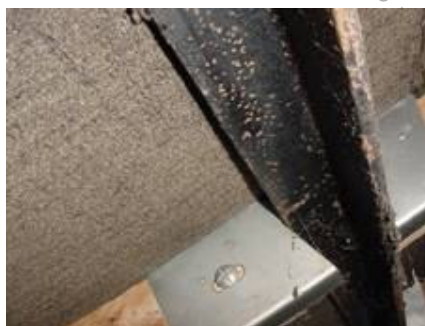
Some fixings replacements/repairs to a non-traditional house

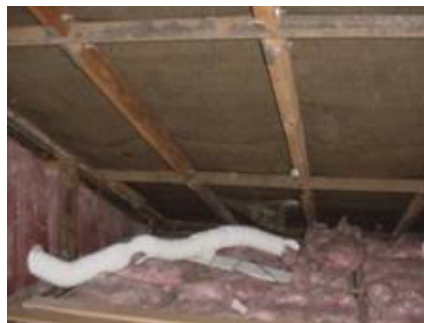
It is very common these days to have a shower/bathroom with an extract system. Does that extract system discharge into the roof or does it discharge out of the building? If it discharges into the roof then there can be problems with rusting and corroding of metal and dampness to timber

Extract vent to outside often discharges into roof which is essential that they do not in this type of roof
