SCHEDULE OF CONDITION

PREPARED IN XXXXX
OF
A Good Food Country Pub

The Schedule of Condition has been prepared by GEM Associates Ltd in xxxxx. The inspection was carried out on Tuesday xxxx and xxxxx. This report does not constitute a Structural Survey (now known as a Building Survey).

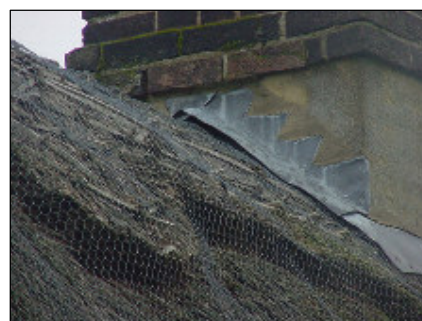
Close up of the lead flashing to the thatch, showing gap.

Action required: Re-form lead and give a watertight bond and check and repair haunching.

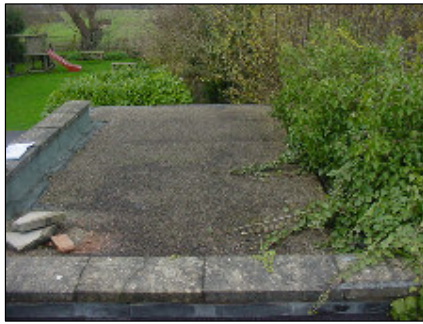
Rear right hand side of roof –
vegetation overgrowing

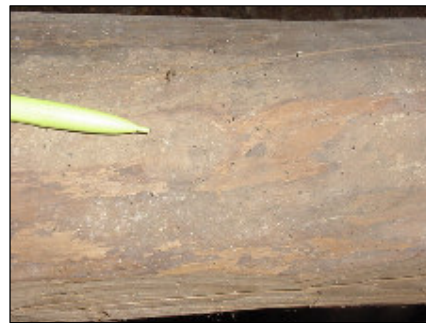
Close up of timber showing woodworm

In the past the woodworm has been extensive and has caused structural problems, which is why we are recommending an anode testing device is used to check if the woodworm is still active (this will have to be carried out in the wood worm breeding season).

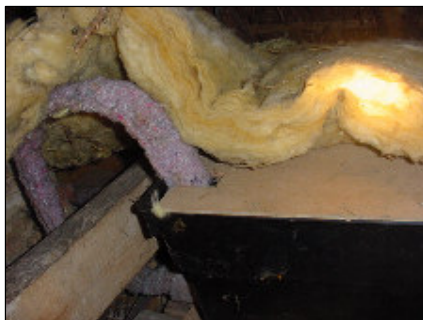
Close up view of plastic water tanks

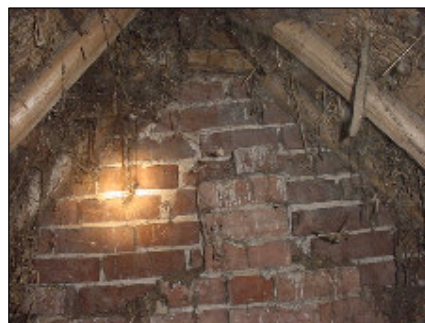
Gable end. The brick size indicates that these have been renewed within the last 100 years

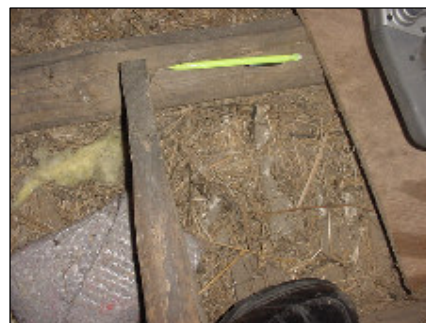
Vertical splits to timber

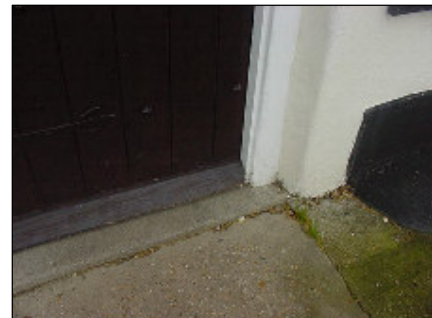
Painted wooden door with vision panel, again ground level is close to door level and water may enter the property through this area during periods of heavy rain.

Ground level close to door level, which may allow water to enter property

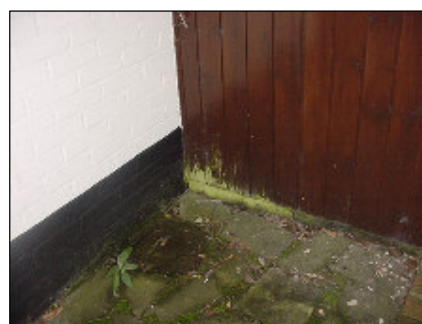
Dampness can be seen to be occurring at the junction with the original brick structure and the conservatory. There is a suspended timber floor beneath this, which we believe will be rotten

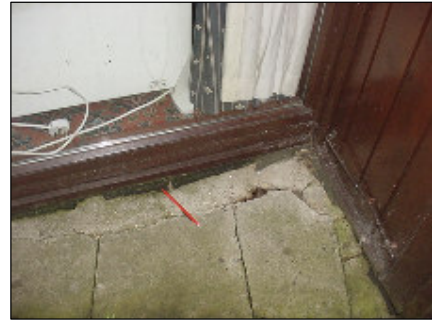
The red pencil indicates the only area where we were able to see a damp proof membrane. This is ineffective as it should be 150 mm above ground level

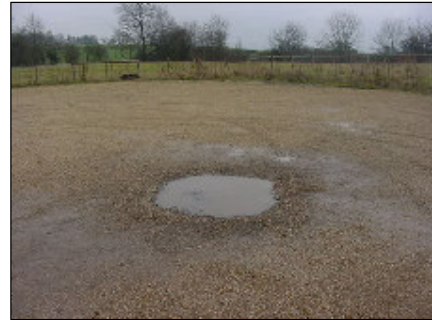
The car park itself is shingled. There are several potholes within the car park, one particular large one opposite the entrance.

Pothole requires filling

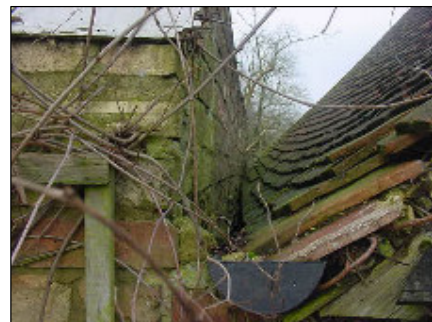
Close up of gully detail

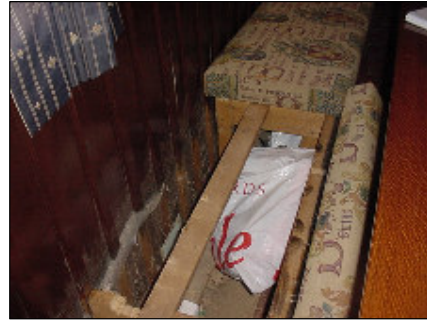
The seats were lifted but unfortunately the walls were not accessible as they are panelled.

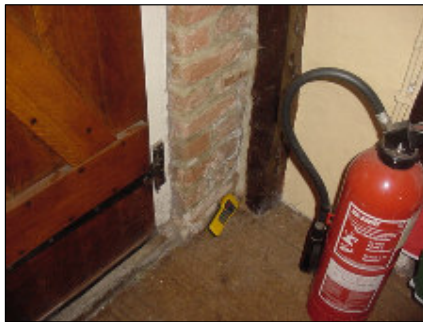
Rising damp on the external wall

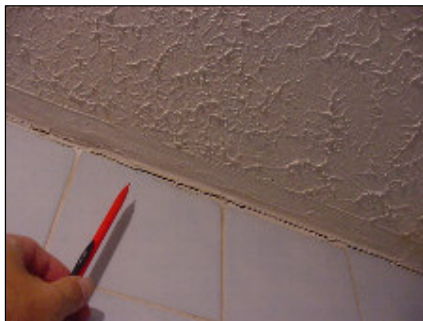
Gap between wall and ceiling
